**ENGINEERING REPORT**

**ANNUAL CCR LANDFILL INSPECTION  
40 CFR §257.84(b)**

**FAYETTE POWER PROJECT  
COMBUSTION BY-PRODUCTS LANDFILL**

**PREPARED BY  
LCRA ENGINEERING SERVICES  
January 15, 2016**

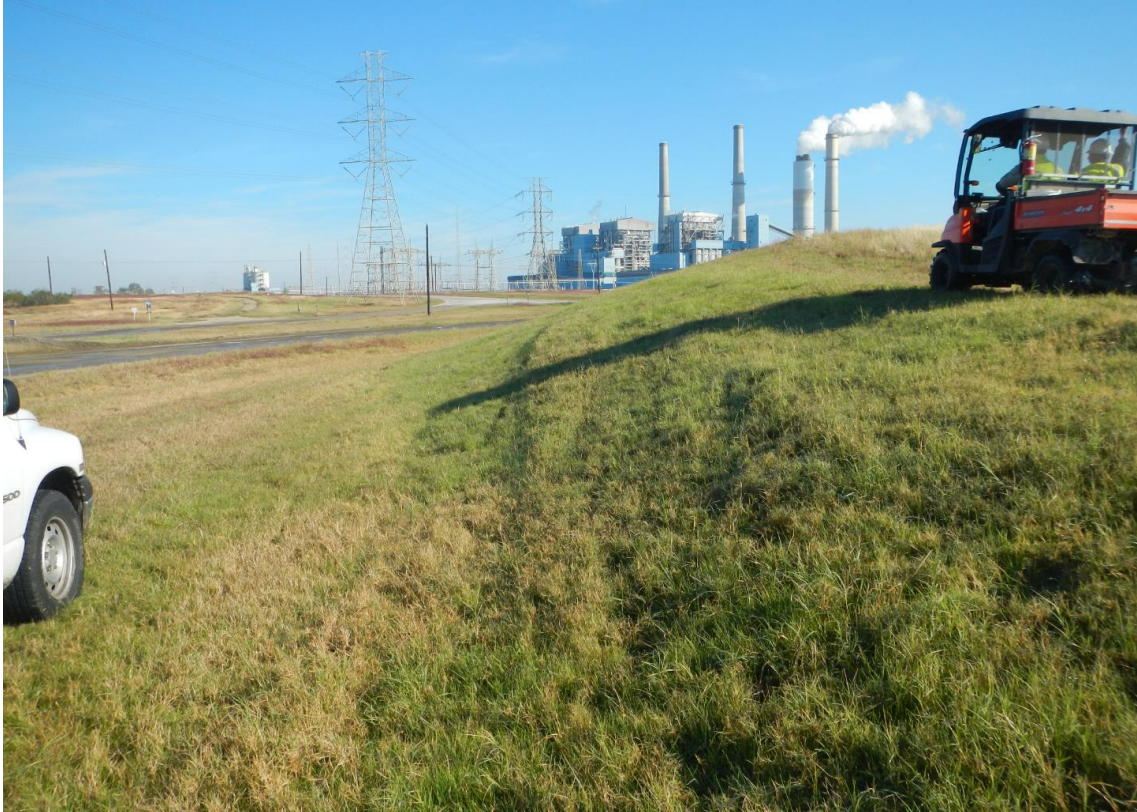
(1) Overall grass cover was in good condition at the time of inspection with an approximate height of 3-inches with very good cover. There were no visual signs of active animal activity or past history of such. The slopes are visually in alignment with the 3:1 design and no visual evidence of structural issues was observed (See Photo 1).

**PHOTO 1 – View of West Embankment from Toe Looking North (12-09-2015)**

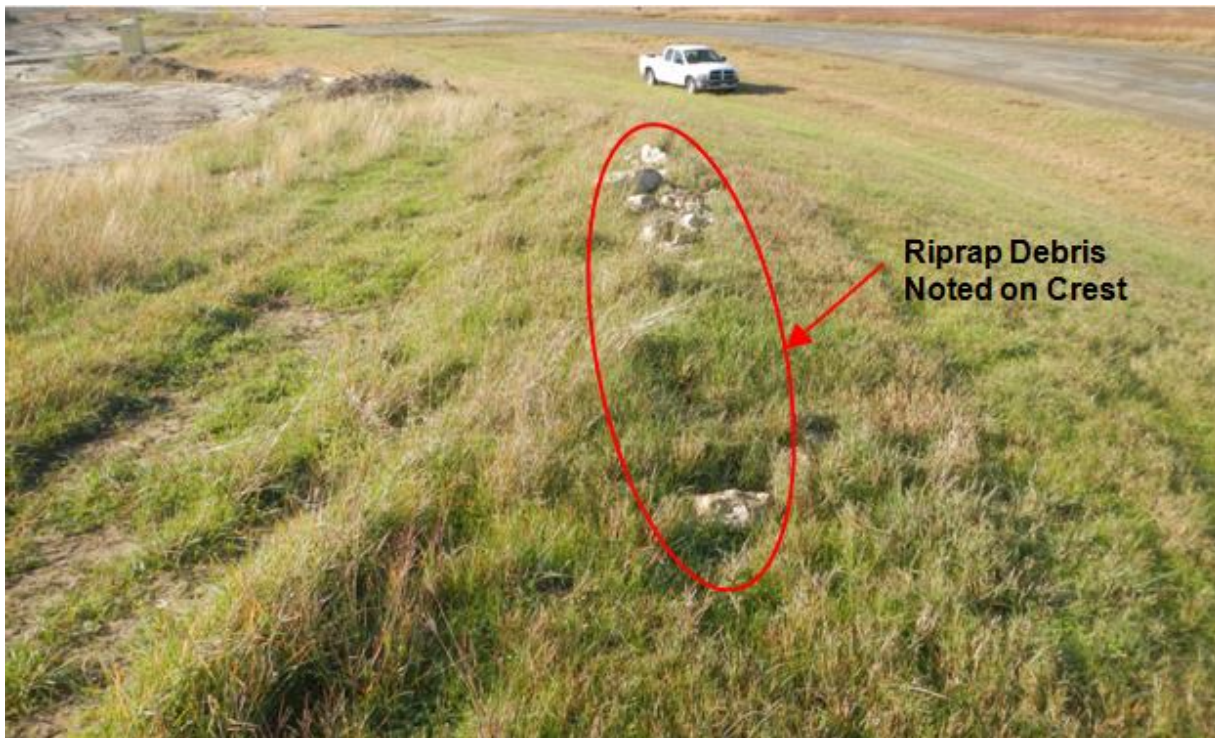
(2) Hard rocky material was present on the crest and appeared to be large broken waste ash material. This riprap rock like debris should be removed from the crest and disposed of in the waste impoundment area to prevent hazards to vehicles traveling on the crest and allow for proper mowing and vegetative growth in this area (See Photo 2). Due to the presence of the debris, this area looked to have been mowed around evidenced by higher grass cover in and around the area.

**PHOTO 2 – View of West Embankment from Crest Looking South (12-09-2015)**

- Item 2015-001, It was reported by FPP staff that the debris noted in Section 4.1, Comment 2 has been removed and properly disposed of within the landfill at the time this report was issued. This is also documented in the weekly inspection report dated December 16, 2015. Landfill slopes and capped areas should be kept clear from debris to prevent damage to the vegetative cover and allow for mowing and inspection activities to occur without debris hazards.

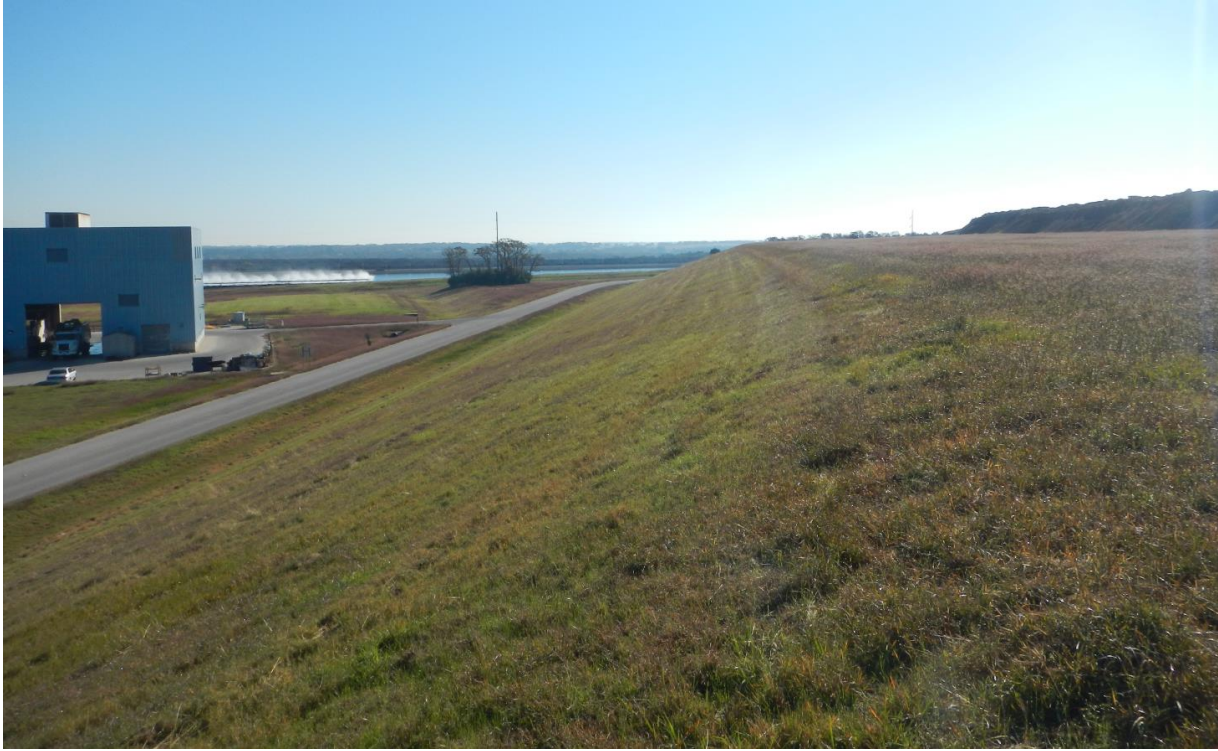
(1) Overall grass cover was in very good condition at the time of inspection with an approximate height of 4 to 6-inches. There were no visual signs of active animal activity or past history of such. The slopes are visually in alignment with the 3:1 design and no visual evidence of structural issues was observed (See Photos 3 &4).

PHOTO 3 – View of North Embankment from Crest Looking East (12-09-2015)

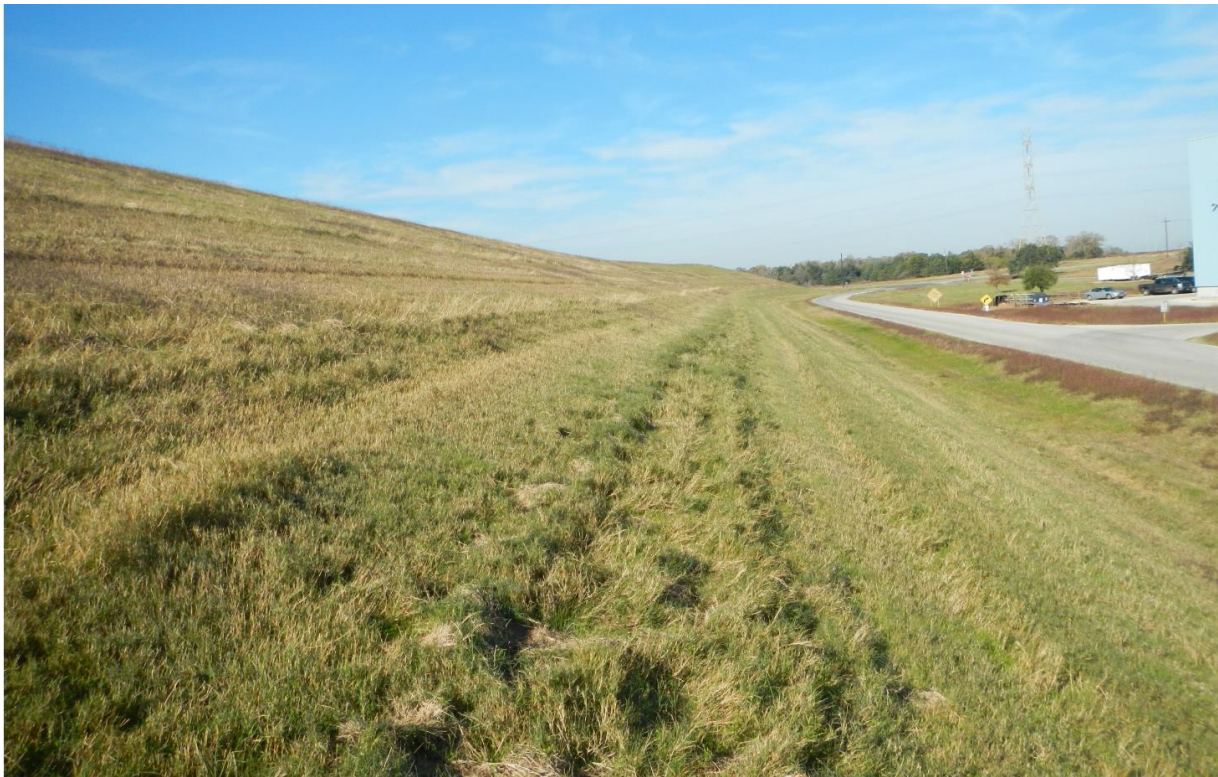
PHOTO 4 – View of North Embankment from Toe Looking West (12-09-2015)

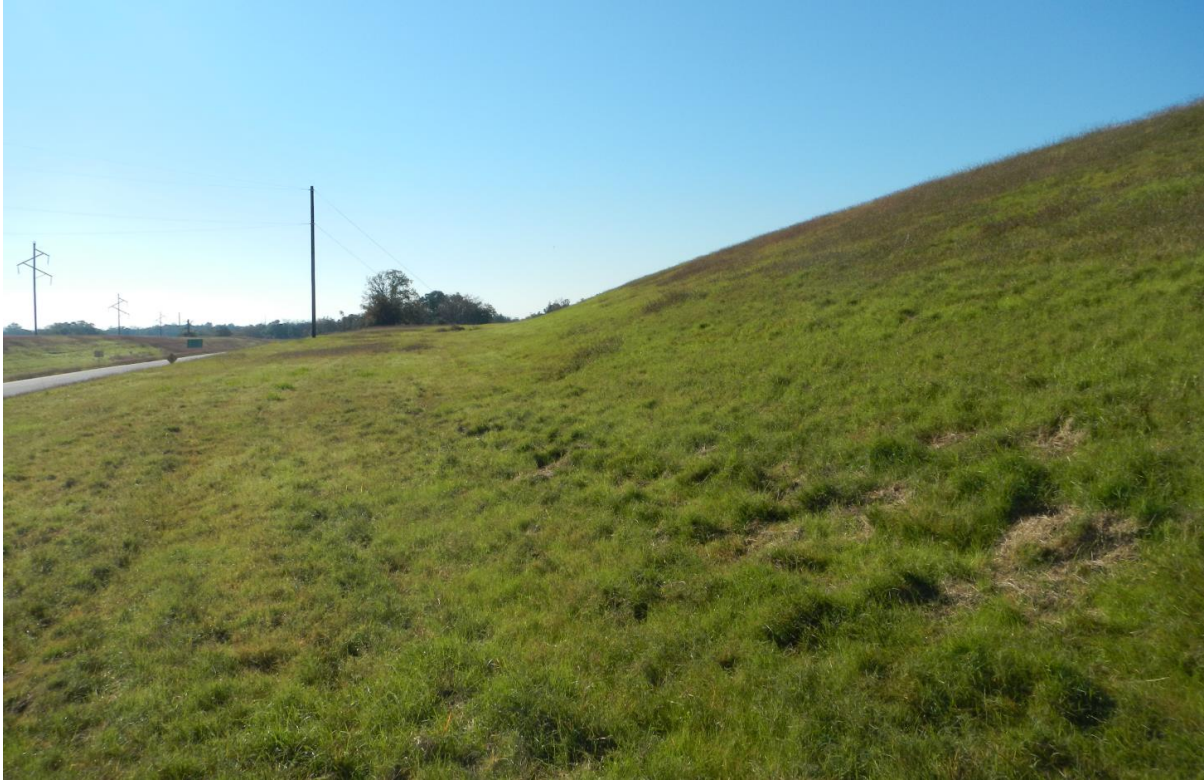
(1) Overall grass cover was in good visual condition at the time of inspection with an approximate height of 6-inches and very good cover. The slopes are visually in alignment with the 3:1 design and no visual evidence of structural issues was observed (See Photos 5 & 7).

PHOTO 5 – View of East Embankment from Toe Looking South (12-09-2015)

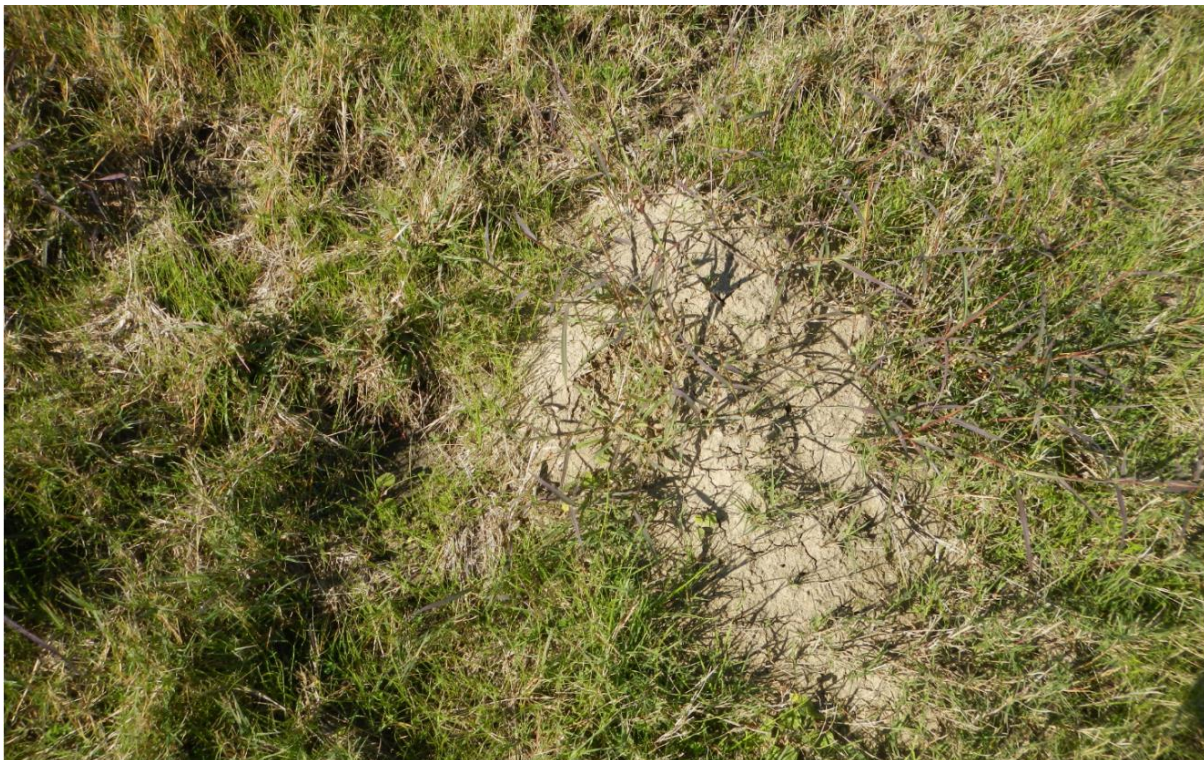
(2) There was an area of apparent minor surface erosion leading to blotchy grass coverage on the north end from the crest extending down approximately 20-ft with a width of approximately 20-ft (See Photo 6). An ant mound was also observed in this same location. There was evidence of water ponding at the crest above this location and although no standing water was present at the time of inspection there was visible ponding to the south (See Photos 9 & 10). It is suspected water may have flowed from this area of ponding at the crest down the slope causing this minor erosion. It should also be noted FPP experienced a 100-year 24 hour storm on October 31 through November 1 approximately 1 month prior to this inspection.

PHOTO 6 – View of Ant Mound and Evidence of Surface Drainage on the North End of East Embankment Slope Near the Crest (12-09-2015)

- Item 2015-002, Evidence of ponding and surface drainage over the slope noted in Section 4.3, Comment 2 should be addressed to prevent progression of minor erosion. The area should be graded to ensure positive drainage in the direction of the interior section of the landfill and ultimately to the stormwater runoff collection and detention system. The landfill manager has been notified of the issue by FPP but had not addressed it at the time of this report due to soil moisture conditions. The issue has been communicated and will be addressed as soon as practical.

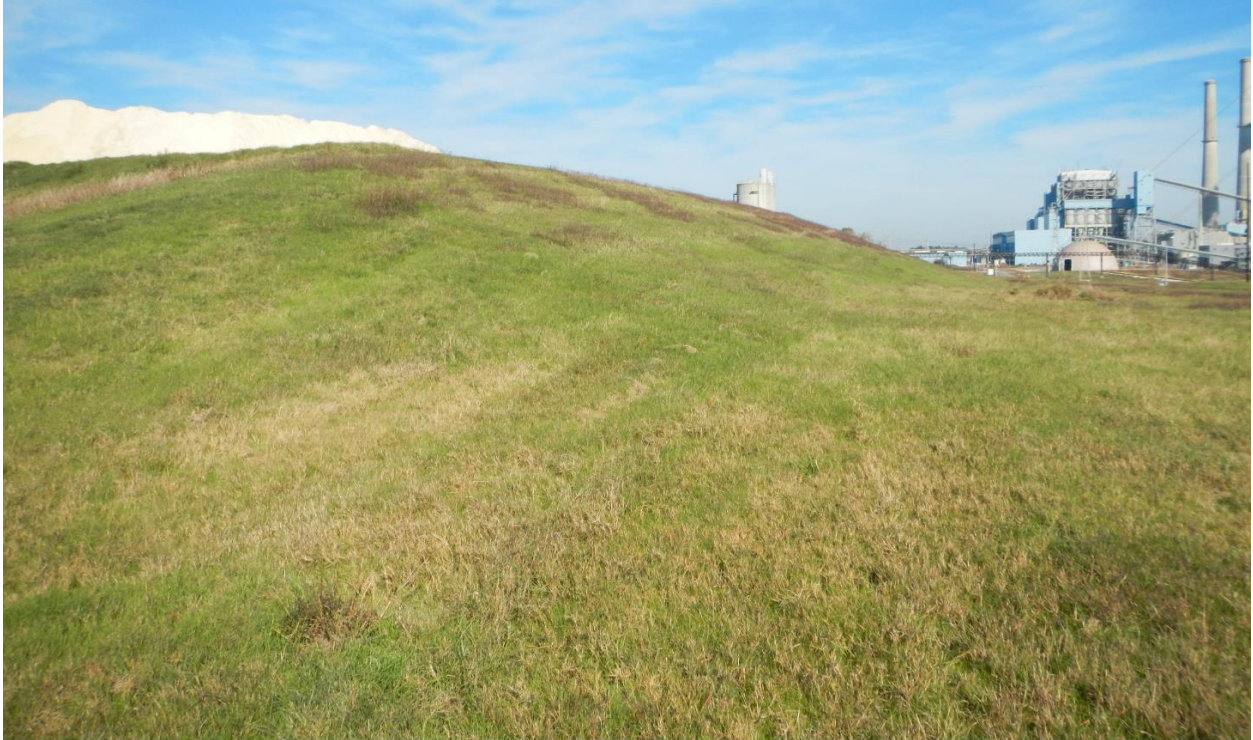
**PHOTO 7 – View of East Embankment from Toe Looking North (12-09-2015)**

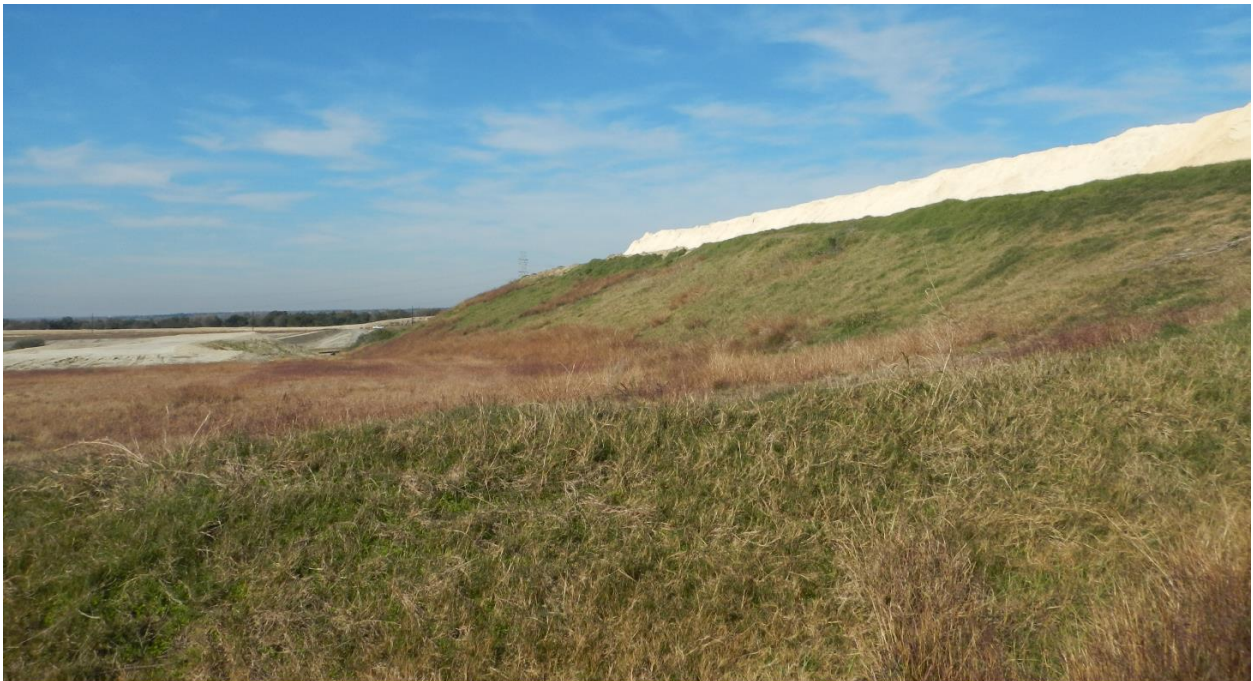
**PHOTO 8 – View of Temporary Cover on South Side of CBL Cell 1 Looking West (12-09-2015)**

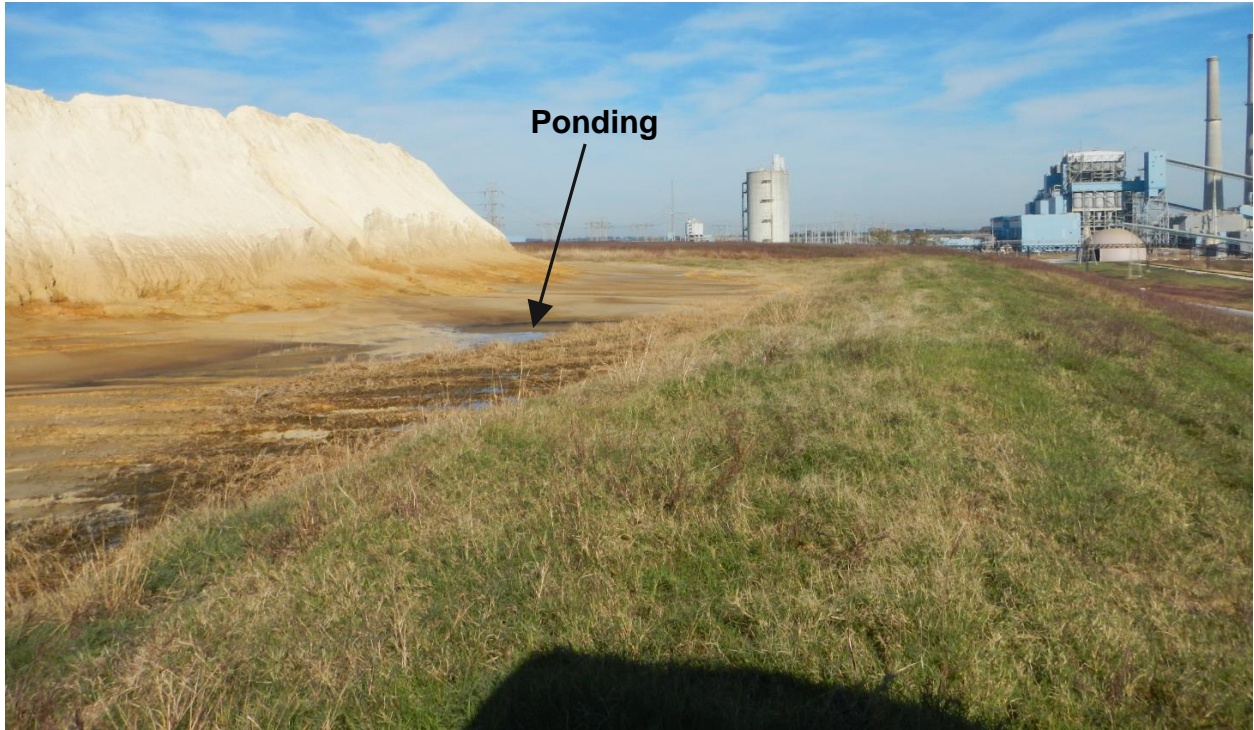
**PHOTO 9 – View of East Embankment Crest Looking North (12-09-2015)**

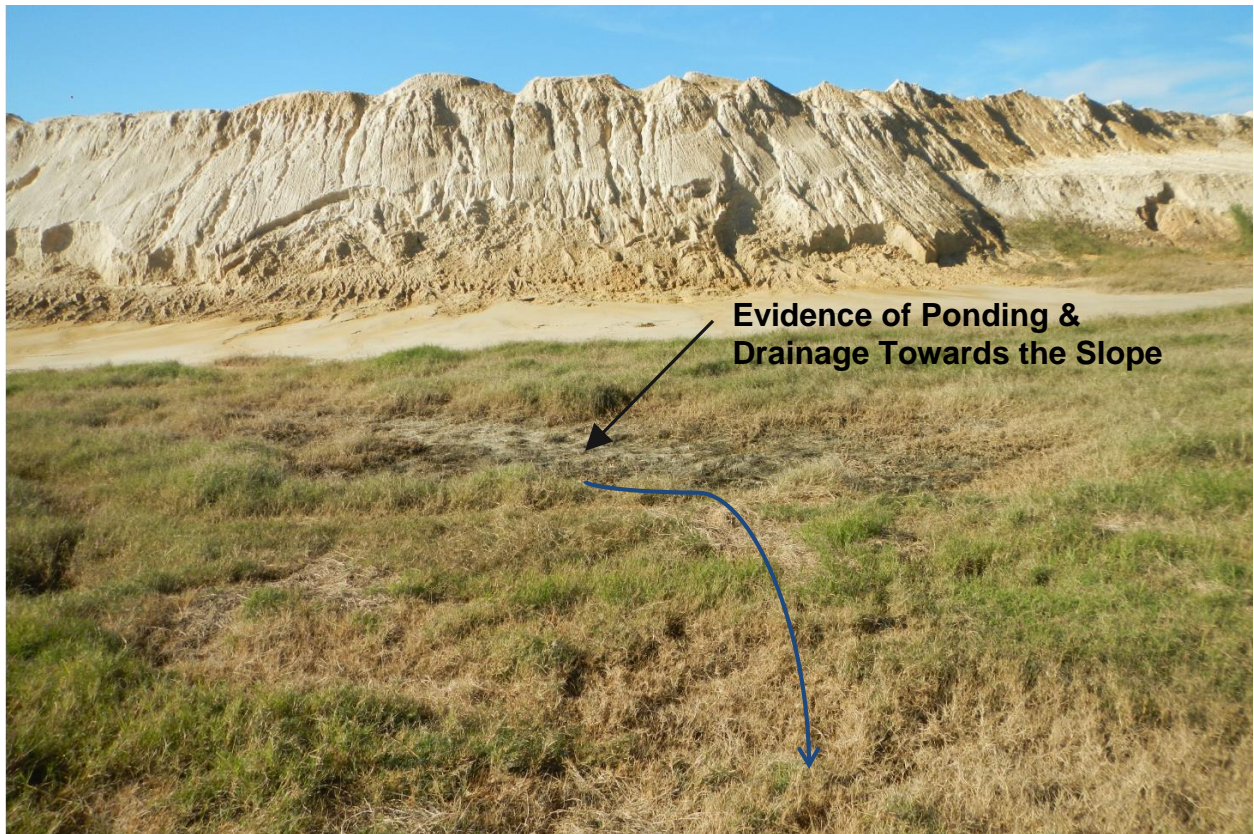
**PHOTO 10 – View of East Embankment Crest at North End (12-09-2015)**

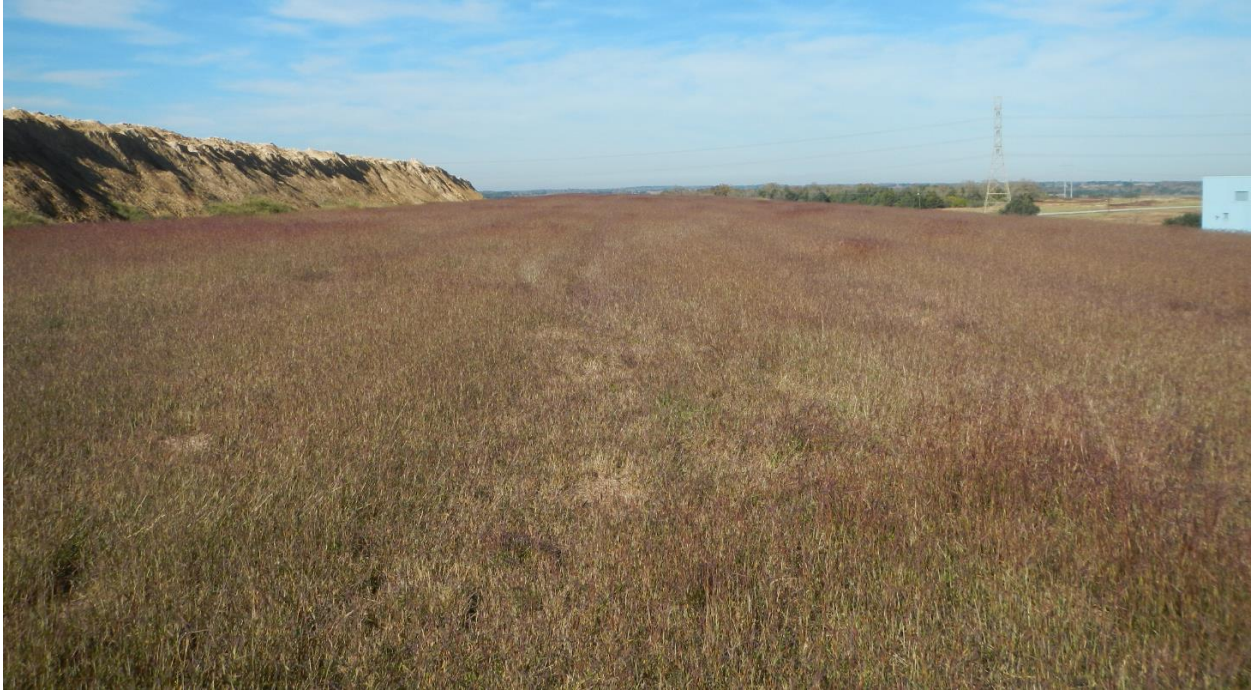
(1) Overall grass cover was in good visual condition at the time of inspection with an approximate height of 18-inches and very good cover. No visible evidence of erosion or structural issues was observed.

**PHOTO 11 – View of Cell 1 Cap from East End of Crest Looking West (12-09-2015)**

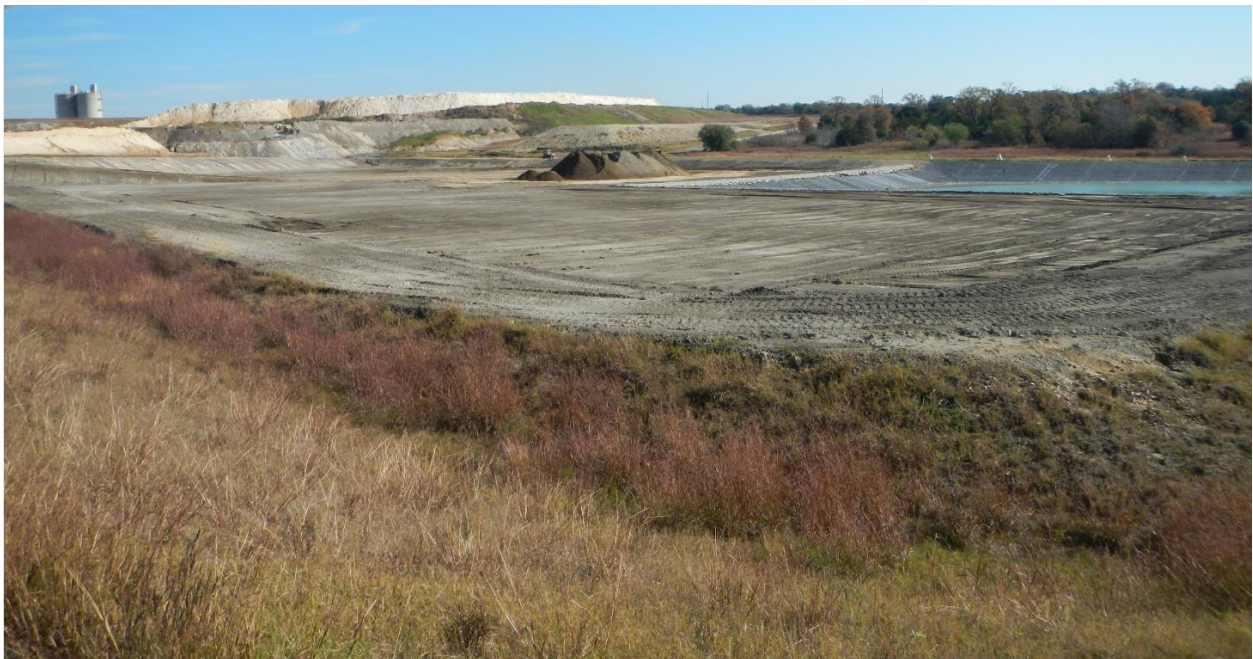
**PHOTO 12 – View of CBL from Southwest Corner of Subcell 2D Storage Area (12-09-2015)**
