**ENGINEERING REPORT**

**ANNUAL CCR LANDFILL INSPECTION**  
**40 CFR §257.84(b)**

**FAYETTE POWER PROJECT**  
**COMBUSTION BY-PRODUCTS LANDFILL**

**PREPARED BY**  
**LCRA ENGINEERING SERVICES**  
**January 13, 2017**

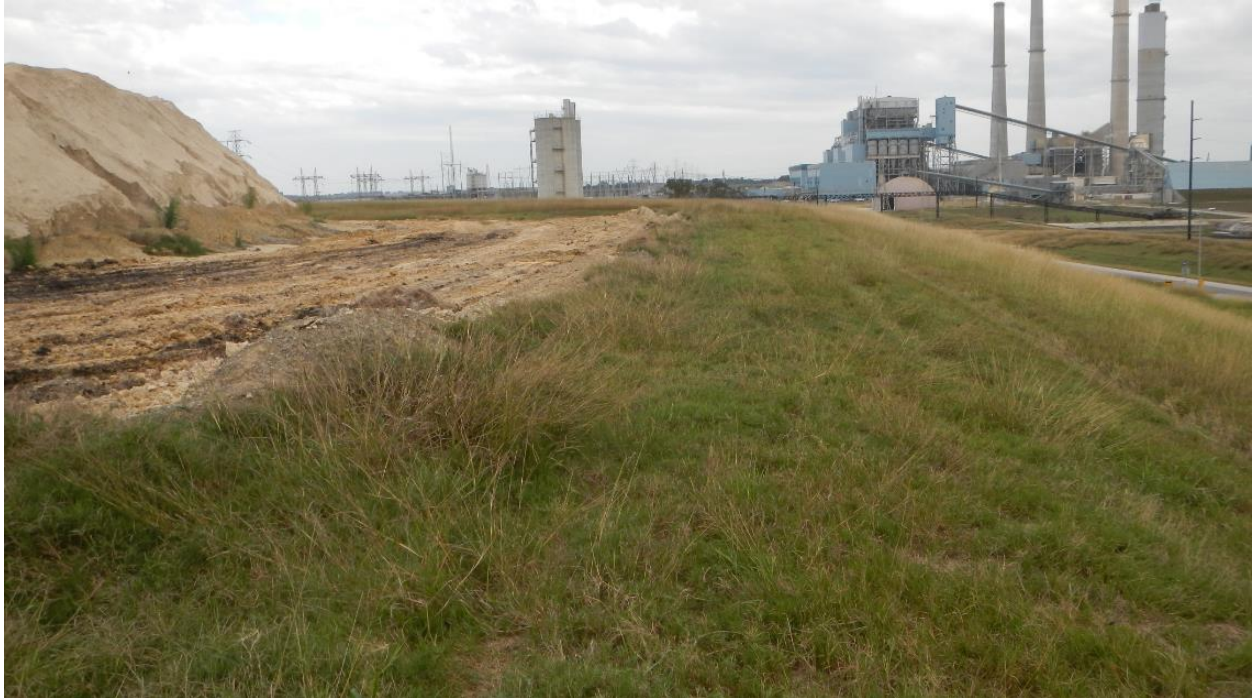
(2) The 2015 inspection area of apparent minor surface erosion leading to blotchy grass coverage on the north end from the crest extending down approximately 20-ft with a width of approximately 20-ft has been repaired by regrading the area. The area has received significant rains over the past year and no evidence of ponding was observed during this inspection due to the regrading (See Photo 1).

**PHOTO 1 – View of East Embankment from Crest Looking North (11-18-2016)**

**This item has been completed and will be removed from future reports. The area has been regraded to prevent ponding and maintain drainage within the CBL storage area.**

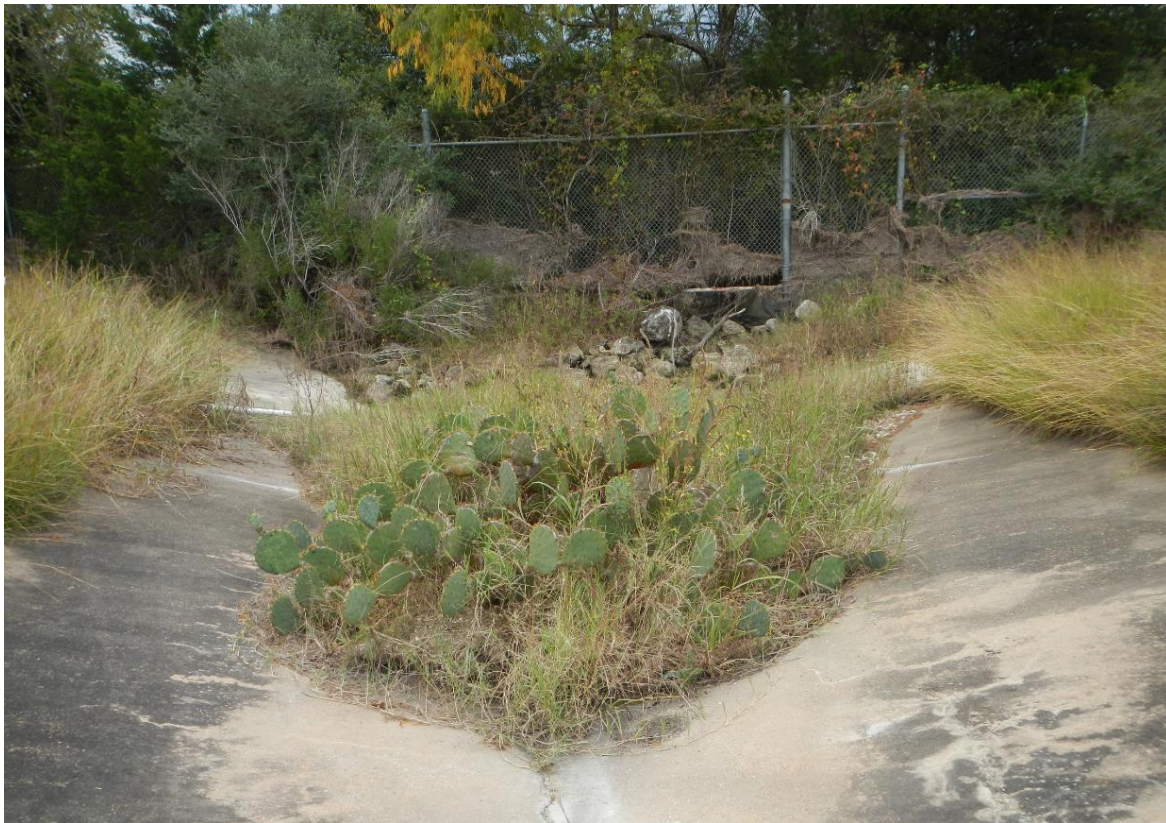
(2) The Combustion Byproducts Landfill (CBL) Runoff Pond spillway was partially obstructed by cactus and brushy growth. This growth should be removed from the spillway (See Photo 2).

**PHOTO 2 – View CBL Runoff Pond Spillway Looking South (11-18-2016)**

- Item 2016-001, Remove vegetation from the CBL Runoff Pond concrete spillway and maintain this area free from brushy obstructions. The spillway was partially obstructed by cactus on the surface and brushy growth in the joints.
- Item 2016-002, Repair the Subcell 2D rock silt berm transition apron. The rock silt berm synthetic liner transition apron has come apart at the top of the Subcell 2D Pond north slope. While synthetic liner was used as part of this silt control measure, this was not a part of the pond liner system and the pond liner is intact.

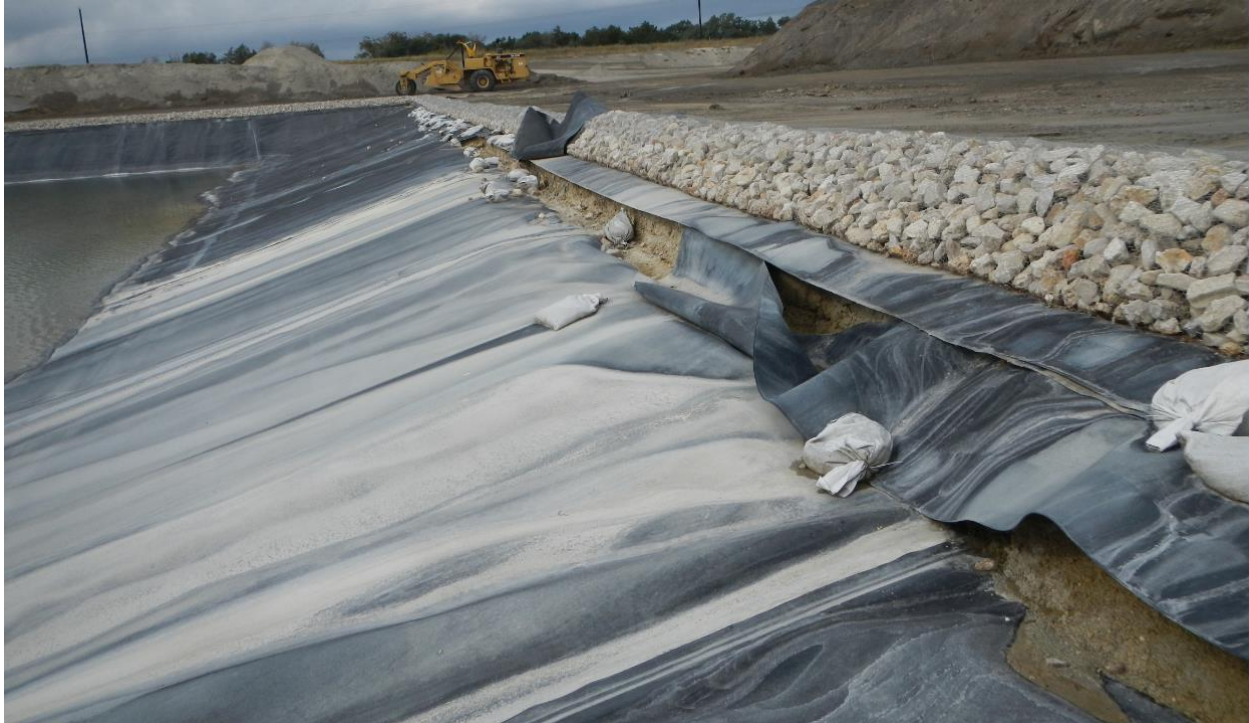
(3) The Subcell 2D rock silt berm synthetic liner transition apron has come apart at the top of the north slope of the Subcell 2D Contact Water Retention Pond. A synthetic liner was used as part of this silt control measure for stormwater flowing from Subcell 2D into the Subcell 2D pond. It is not a part of the pond liner system and the pond liner is intact. (See Photo 3).

**PHOTO 3 – View of Subcell 2D Pond North Slope Rock Silt Berm (11-18-2016)**
