**ENGINEERING REPORT**

**ANNUAL CCR LANDFILL INSPECTION  
40 CFR §257.84(b)**

**FAYETTE POWER PROJECT  
COMBUSTION BY-PRODUCTS LANDFILL**

**PREPARED BY  
LCRA ENGINEERING SERVICES  
January 14, 2019**

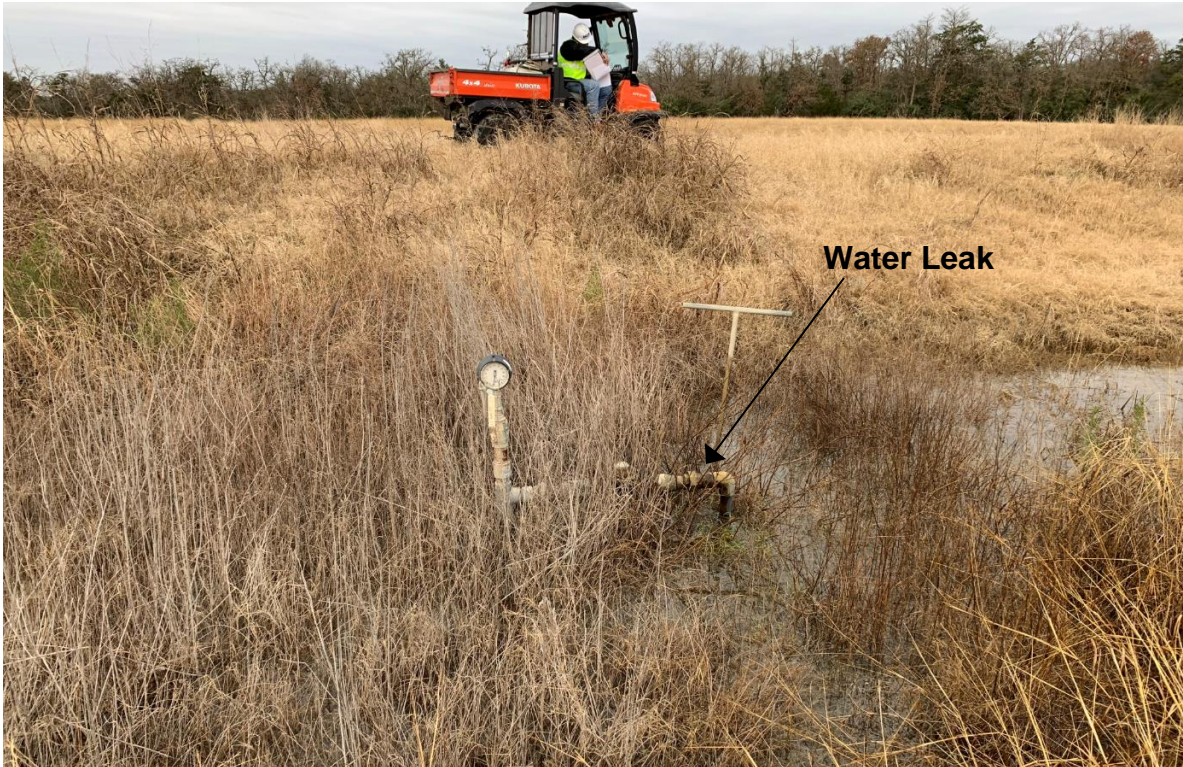
(2) Standing water and an active leak was observed on the upstream side of the water meter located at the beginning of the western embankment on the inside of the CBL (See Photo 1). Water was actively leaking from the male adaptor on the upstream side of the union for the water meter. This should be repaired to prevent standing water and ground saturation.

**PHOTO 1 – View of leaking water meter upstream side of the West Embankment (12-12-2018)**

- Item 2018-001, Repair the active leak observed on the upstream side of the water meter located at the beginning of the western embankment on the inside of the CBL to prevent standing water and ground saturation.
- Item 2018-002, Contact the design engineer, liner installer and liner manufacturer, to inform them of the current condition of the Cell 2D HDPE liner and consult with them on additional opinions of possible cause, recommendations, and any need for repairs.
- Item 2018-003, Clear waste material from in front of the two roadway crossing corrugated metal drainage culverts, which convey contact runoff from Existing Cell 1 to the Existing Runoff Retention Pond near the intersection of Future Subcell 2A, 2B and Existing Subcell 2D. These should be maintained regularly to ensure full culvert design capacity.

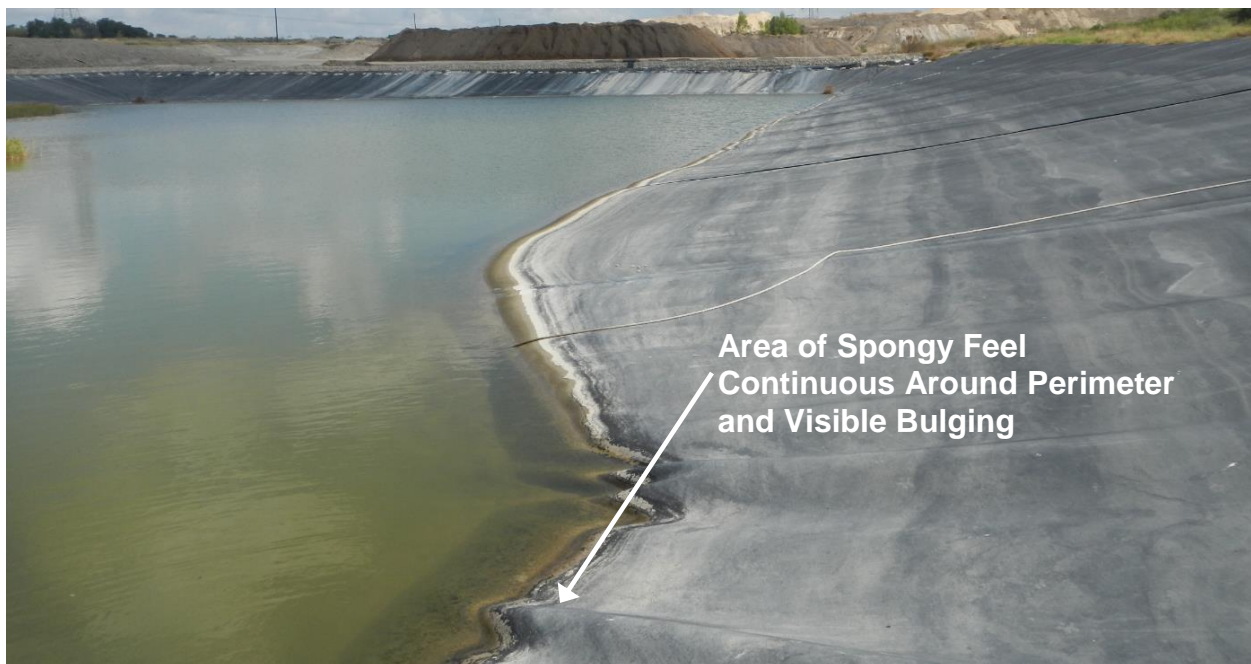
(1) Water was noted under the Cell 2D Pond during the August 2, 2018 weekly inspection report. The site was visited on August 16, 2018 along with FPP staff and LCRA Environmental staff to investigate the finding. There appeared to be water under the liner as reported based on movement of the liner when walking on it down at the water surface elevation. This was observed by tapping on the liner with one foot resulting in a clapping sound. This sound was made as the liner interacted with the water surface below. The areas with water under them also had a different feel when applying force with one foot on the solid slope and one foot on the liner surface with water under it. This may be described as more spongy, like the feel when pressing on water filled bladder. From these observations, it was assumed the maximum water surface elevation below the liner was constant around the entire pond at the time of this site visit. The elevation appeared to be equal to the pond's water surface elevation. The same condition was again observed during the December 16, 2018 inspection (See photo 2).

The design records for the Cell 2D Pond were reviewed based on the observed conditions. It should be noted that the Cell 2D Pond liner design incorporates a two component liner system with a low permeability soil liner overlain by a synthetic high density polyethylene liner. It was noted in the design documents that; “The functions of the two liner components are complementary.” and “The HDPE geomembrane is non-porous, but may have an occasional very small hole not detected through construction quality assurance. The underlying compacted soil layer is porous, but has a low permeability and impedes flow through any geomembrane hole. When used together in a composite liner, the two materials greatly diminish the potential for liner leakage compared to the potential for leakage through a geomembrane liner or a compacted soil liner alone.” Therefore, if the HDPE geomembrane has developed a leak, the design intent is for the water under the HDPE geomembrane to be contained within the clay liner component.

**PHOTO 2 – View of Cell 2D Pond HDPE liner looking west at the Northeast corner (8-16-2018)**

It was recommended after the August inspection to contact the design engineer, liner installer and manufacturer, to inform them of the current condition and consult with them on additional opinions of possible cause, recommendations, and any need for repairs. After review of the original design contract and liner installation warranty information, it was determined that the only warranty remaining was associated with liner material. Therefore, LCRA is in the process of having a liner repair company evaluate the liner system.

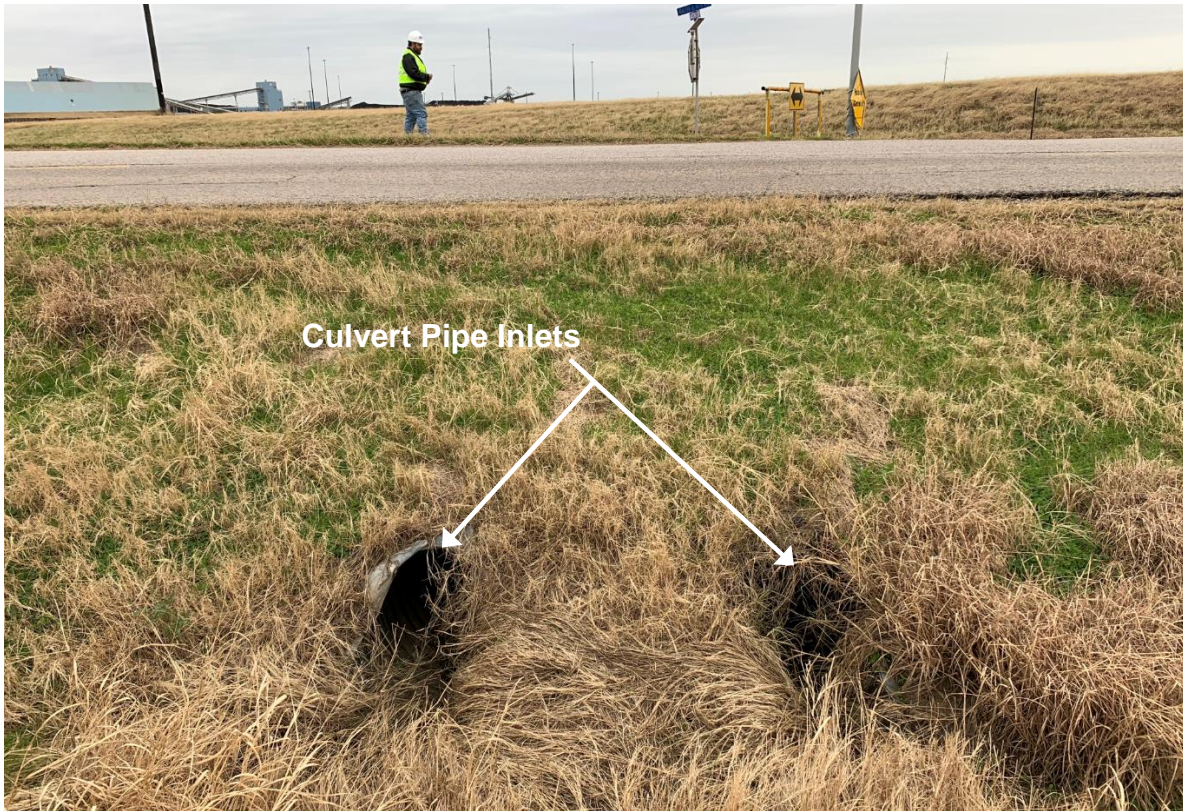
(1) The minor damage identified in the 2017 Inspection Report at one of the corrugated metal drainage culverts which convey non-contact runoff from the closed northern slope section beneath the Austin Loop plant road has been repaired (See Photo 3).

**PHOTO 3 – View of repaired North Embankment culverts looking Northeast (12-12-2018)**

- Item 2017-001, It was identified during the 2018 inspection that the damaged inlet sections of corrugated metal drainage culverts which convey non-contact runoff from the northern embankment section beneath the plant road have been repaired. This item was noted as completed in the weekly inspection report dated March 28, 2018.

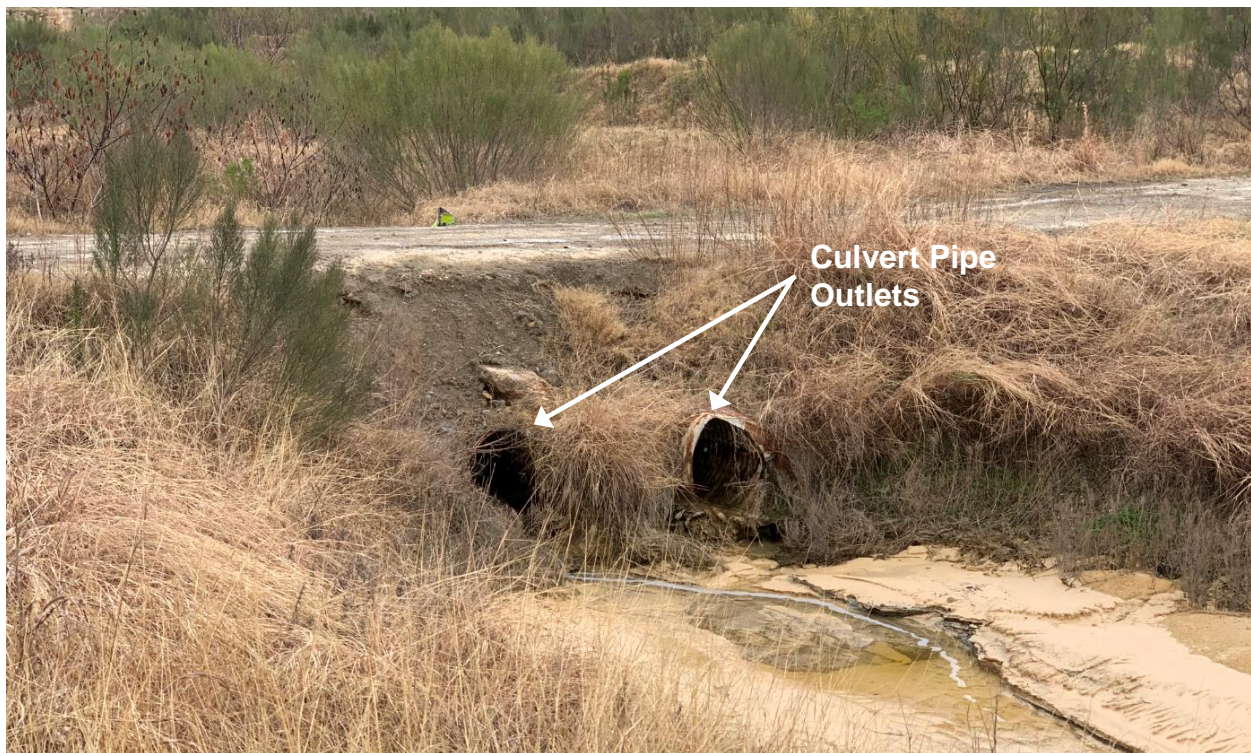
(2) Damage identified in the 2017 Inspection Report at the two roadway crossing corrugated metal drainage culverts, which convey contact runoff from Existing Cell 1 to the Existing Runoff Retention Pond near the intersection of Future Subcell 2A, 2B and Existing Subcell 2D has been repaired (See Photo 4). The upstream side of this culvert was silted in to approximately half the pipe on the right entrance and approximately three fourths the pipe on the left entrance. These should be maintained clear to ensure full culvert design capacity (see Photo 5).

**PHOTO 4 – View of repaired Cell 1 stormwater channel culverts looking Northeast (12-12-2018)**

- Item 2017-002, It was identified during the 2018 inspection that repairs have been made to the damaged corrugated metal drainage culvert ends near the intersection of Future Subcell 2A, 2B and Existing Subcell 2D, which convey contact runoff via the Runoff Channel from Existing Cell 1 beneath the access road to the Existing Runoff Retention Pond.

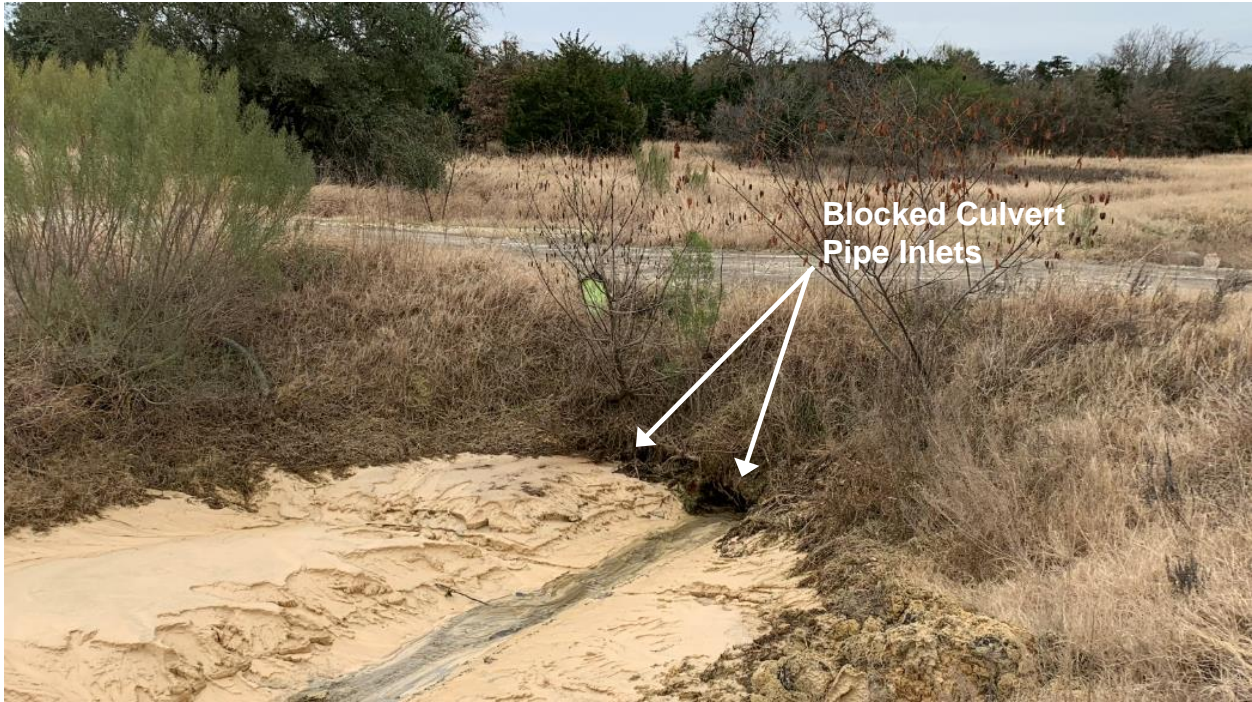
**PHOTO 5 – View of Cell 1 Stormwater Channel culverts looking Southeast (12-12-2018)**
