ENGINEERING REPORT

**ANNUAL CCR LANDFILL INSPECTION
40 CFR §257.84(b)
30 TAC §352.841**

**FAYETTE POWER PROJECT
COMBUSTION BY-PRODUCTS LANDFILL
TX Registration No. CCR101
EPA Identification No. TXD083566547**

**PREPARED BY
LCRA WATER ENGINEERING
January 7, 2023**

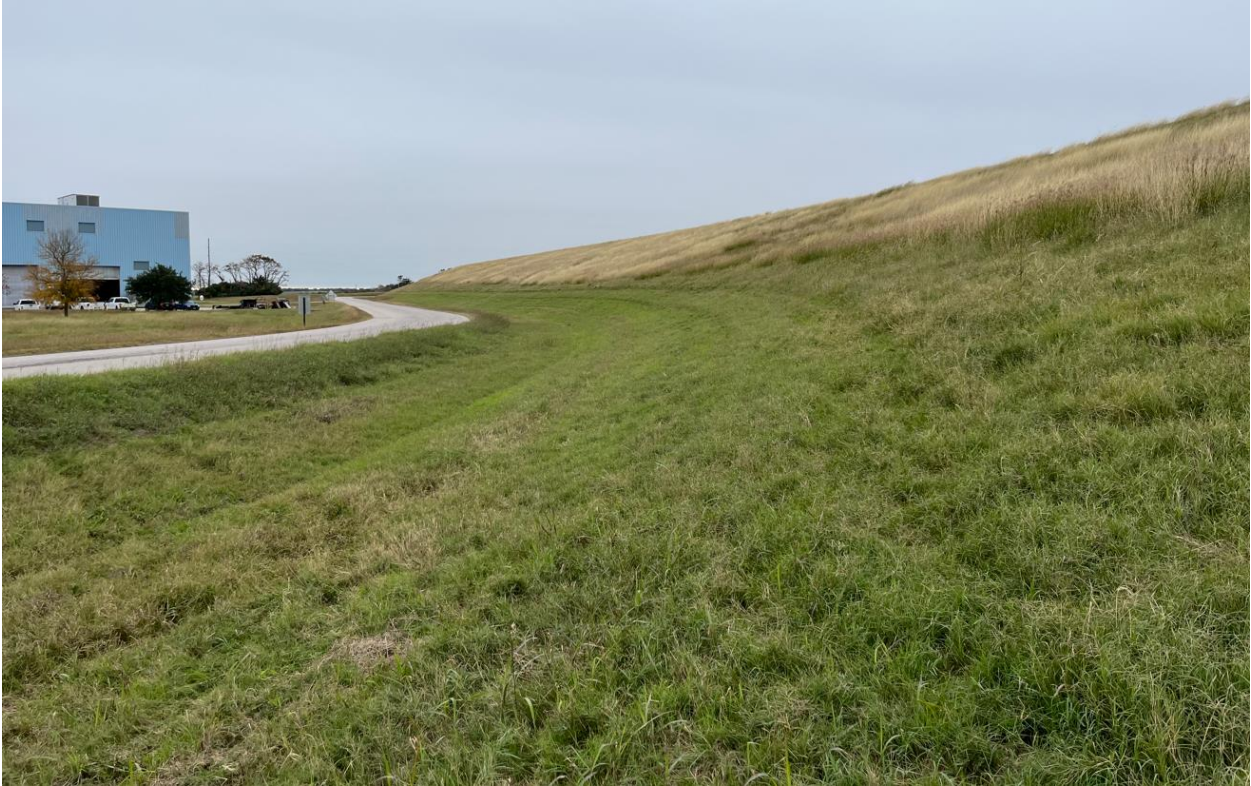
(1) Overall, grass cover was in good condition with full coverage. Grass was observed with an approximate height of 12 to 36-inches on the slope and recently mowed with an approximate height of 3 to 5-inches at the crest. There were no visual signs of active animal activity or history of such. The slopes are visually in alignment with the 3:1 design and no visual evidence of structural issues were observed. The structure was observed to be containing the CCR materials as designed.

PHOTO 1 – View of Cell 1 North Embankment Looking East (12-01-2022)

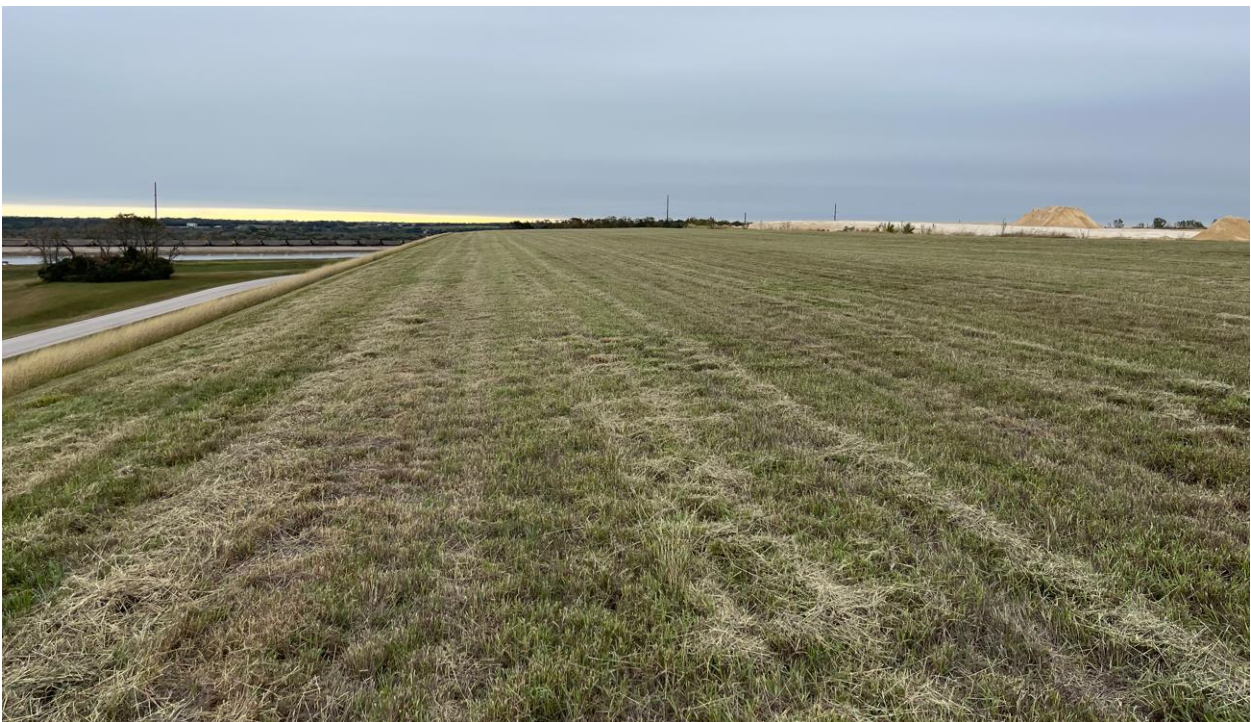
Overall, grass cover was in good condition with full coverage. Grass was observed to be recently mowed with an approximate height of 3 to 6-inches. There were no visual signs of active animal activity or history of such. No visible evidence of structural issues was observed. The structure was observed to be containing the CCR materials as designed.

PHOTO 2 – View of Cell 1 Temporary Cap and Landfill Material Looking East (12-01-2022)

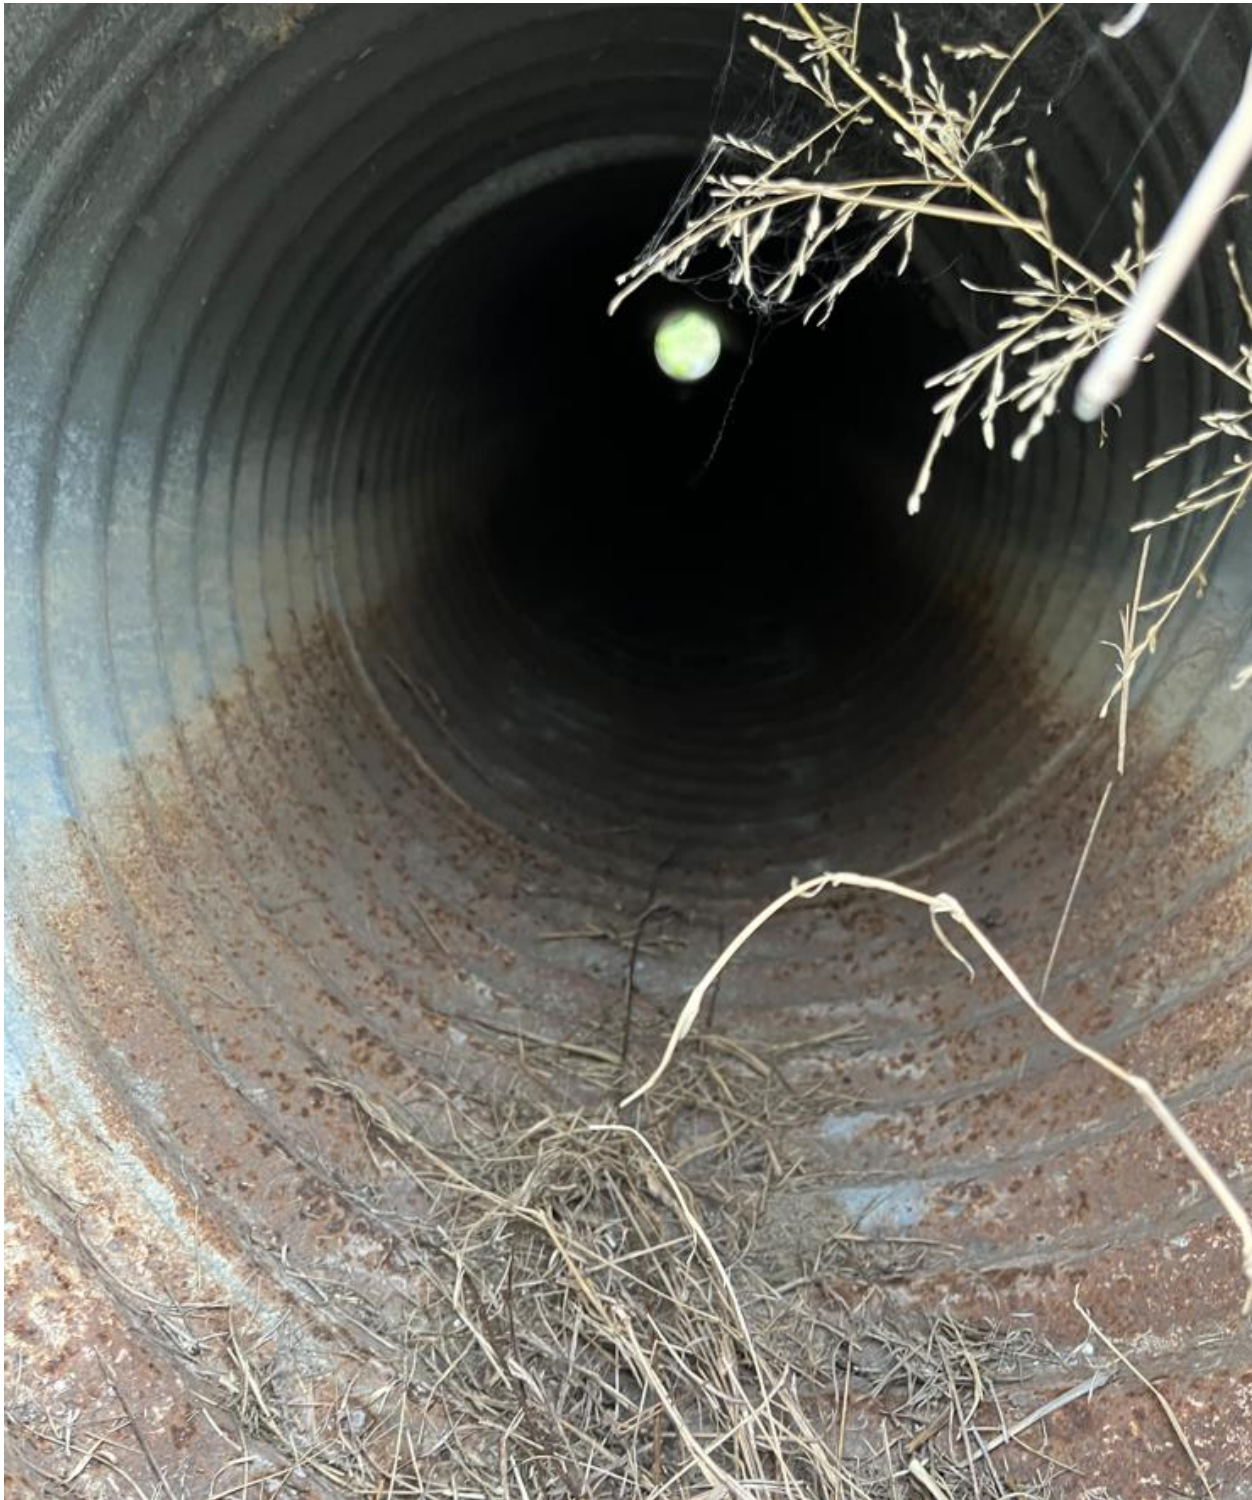
(1) There were no conditions observed as disrupting or having the potential to disrupt the operation or safety of the CBL.

PHOTO 3 – View of Properly Functioning Non-Contact Water Drainage Culvert Pipe at Northeast Corner of Cell 1 (12-01-2022)
