ENGINEERING REPORT

**ANNUAL CCR LANDFILL INSPECTION
40 CFR §257.84(b)
30 TAC §352.841**

**FAYETTE POWER PROJECT
COMBUSTION BY-PRODUCTS LANDFILL
TX REGISTRATION NO. CCR101
EPA IDENTIFICATION NO. TXD083566547**

January 8, 2024

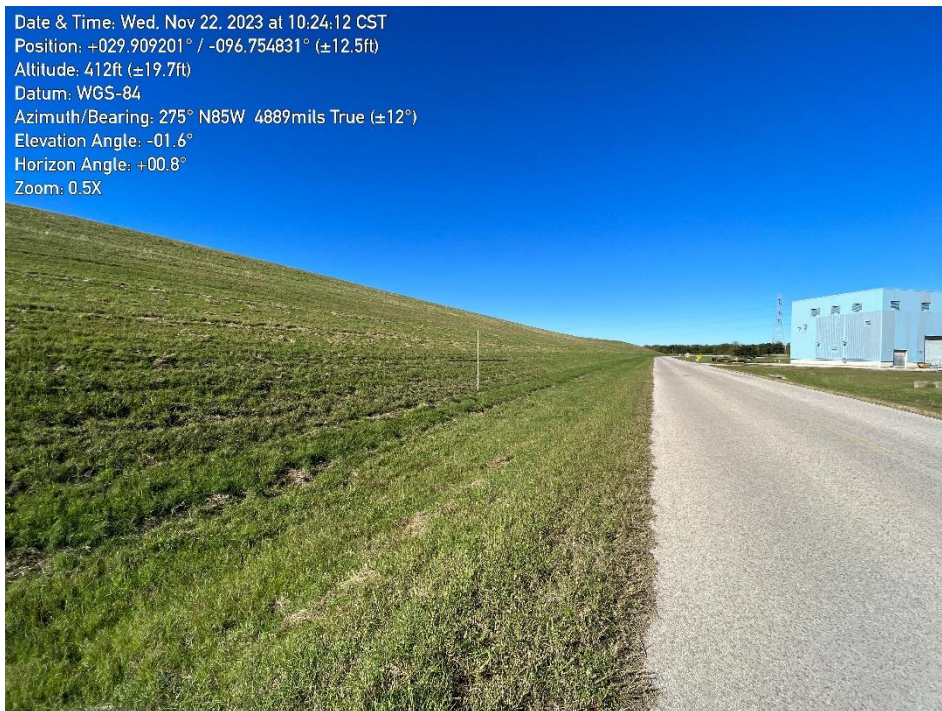
- (1) Overall, grass cover was in good condition throughout. The area was recently mowed and was observed to have an average vegetation length of approximately 4-inches. There were no signs of animal damage or a history of such. The slopes were visually in alignment with the 3:1 design and no visual evidence of structural issues were observed. The structure was observed to be containing the CCR materials as designed.

Photo 1 – Cell 1 North Embankment, Facing West

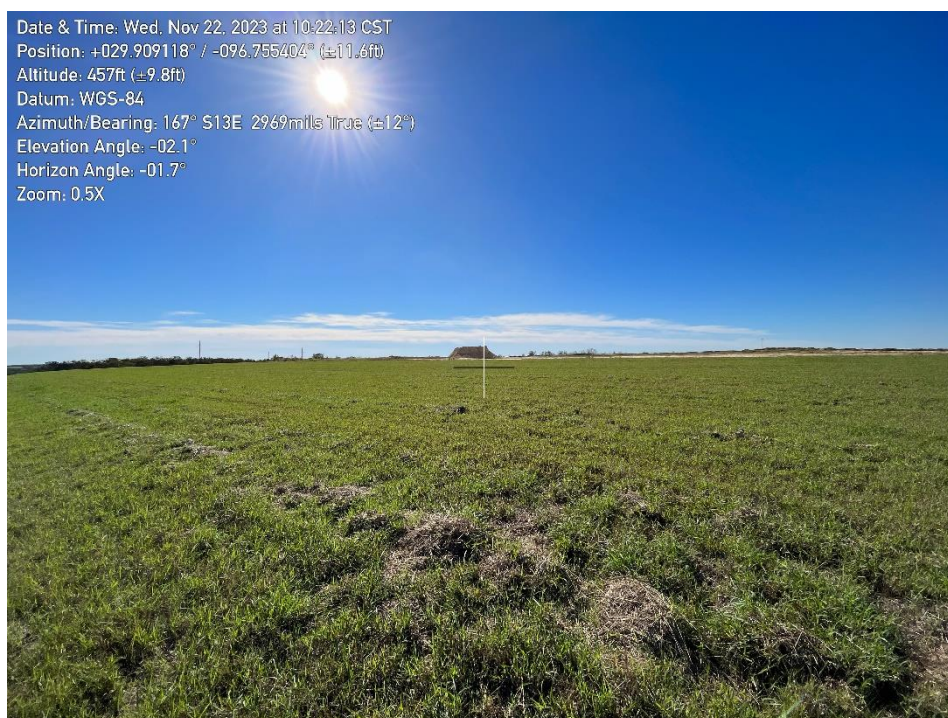
- (1) Overall, grass cover was in good condition throughout. The area was recently mowed and was observed to have an average vegetation length of approximately 4-inches. There were no signs of animal damage or a history of such. There was no visual evidence of structural issues observed. The structure was observed to be containing the CCR materials as designed.

Photo 2 – Cell 1 Capped Area (foreground) and Landfill Material (background), Facing Southeast

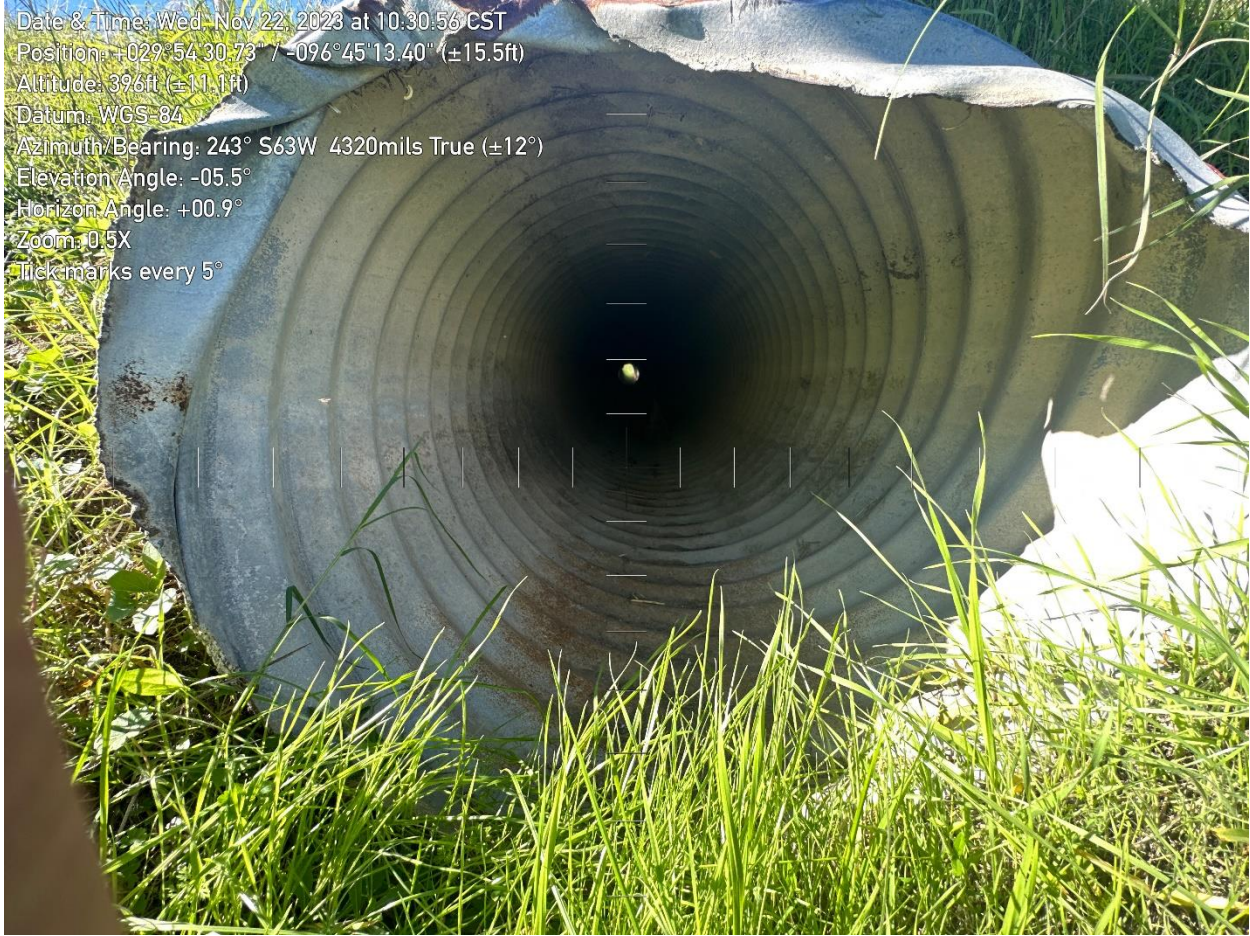
Photo 3 – Non-Contact Water Drainage Culvert at Northeast Corner of Cell 1, Facing Southwest
