ENGINEERING REPORT

**ANNUAL CCR LANDFILL INSPECTION
40 CFR §257.84(b)
30 TAC §352.841**

**FAYETTE POWER PROJECT
COMBUSTION BY-PRODUCTS LANDFILL
TX REGISTRATION No. CCR101
EPA IDENTIFICATION No. TXD083566547**

January 8, 2025

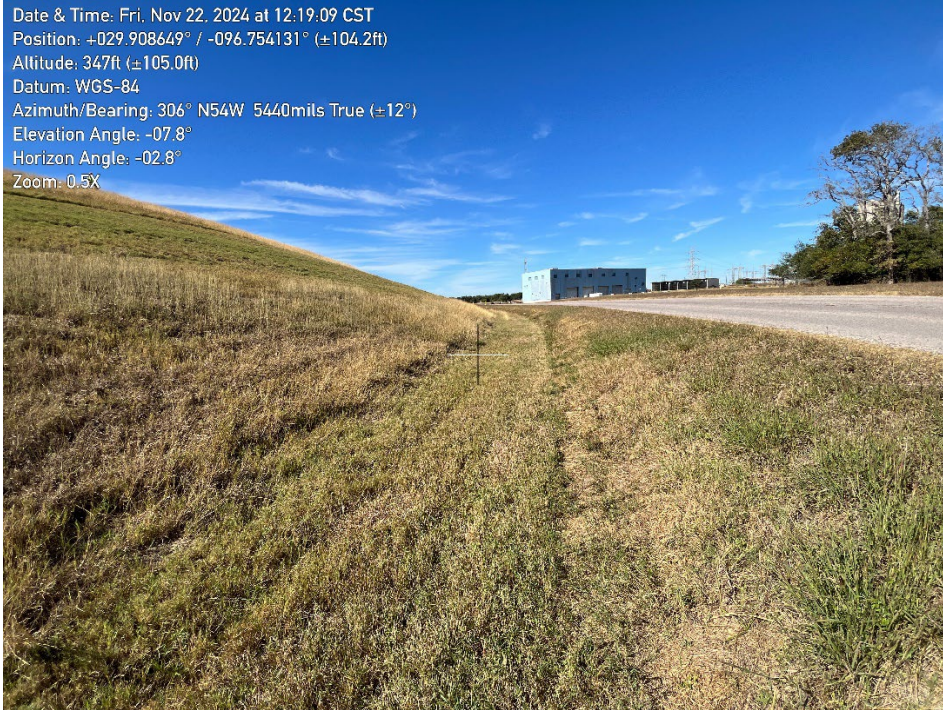
Photo 1 – Cell 1 North Embankment, Facing Northwest

- (1) Overall, grass cover was in good condition throughout. The area was recently mowed and was observed to have an average vegetation length of approximately 4-inches. There were no signs of animal damage or a history of such. The slopes appeared to be in alignment with the 3:1 design and no visual evidence of structural issues were observed. The structure was observed to be containing the CCR materials as designed.

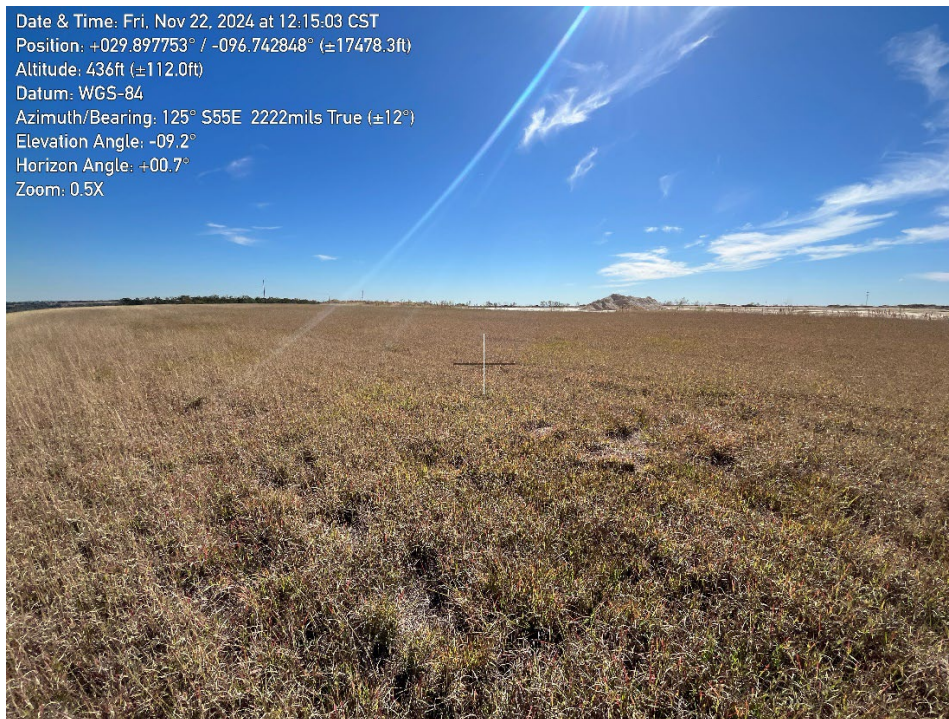
Photo 2 – Cell 1 Capped Area (foreground) and Landfill Material (background), Facing Southeast

- (1) Overall, grass cover was in good condition throughout. The area was recently mowed and was observed to have an average vegetation length of approximately 4-inches. There were no signs of animal damage or a history of such. There was no visual evidence of structural issues observed. The structure was observed to be containing the CCR materials as designed.

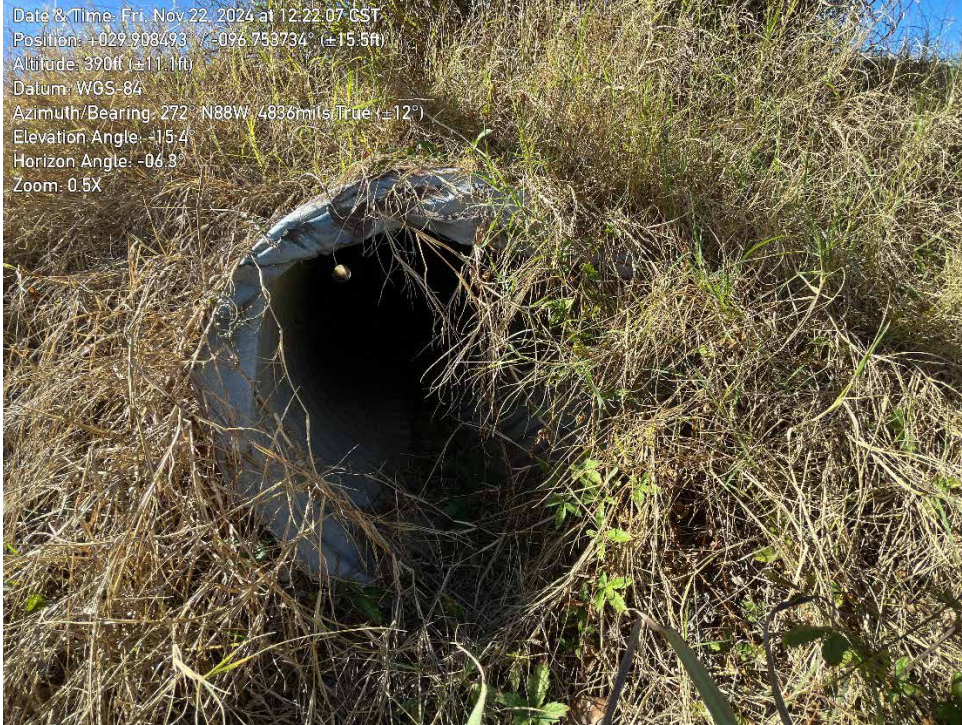
Photo 3 – Non-Contact Water Drainage Culvert at Northeast Corner of Cell 1, Facing Southwest

- (1) All stormwater drainage channels and culverts were observed to be in good condition and appeared to be operating as designed. There were no conditions observed as disrupting or having the potential to disrupt the operation or safety of the CBL.
