**ENGINEERING REPORT**

**ANNUAL CCR LANDFILL INSPECTION  
40 CFR §257.84(b)**

**FAYETTE POWER PROJECT  
COMBUSTION BY-PRODUCTS LANDFILL**

**PREPARED BY  
LCRA ENGINEERING SERVICES  
January 12, 2018**

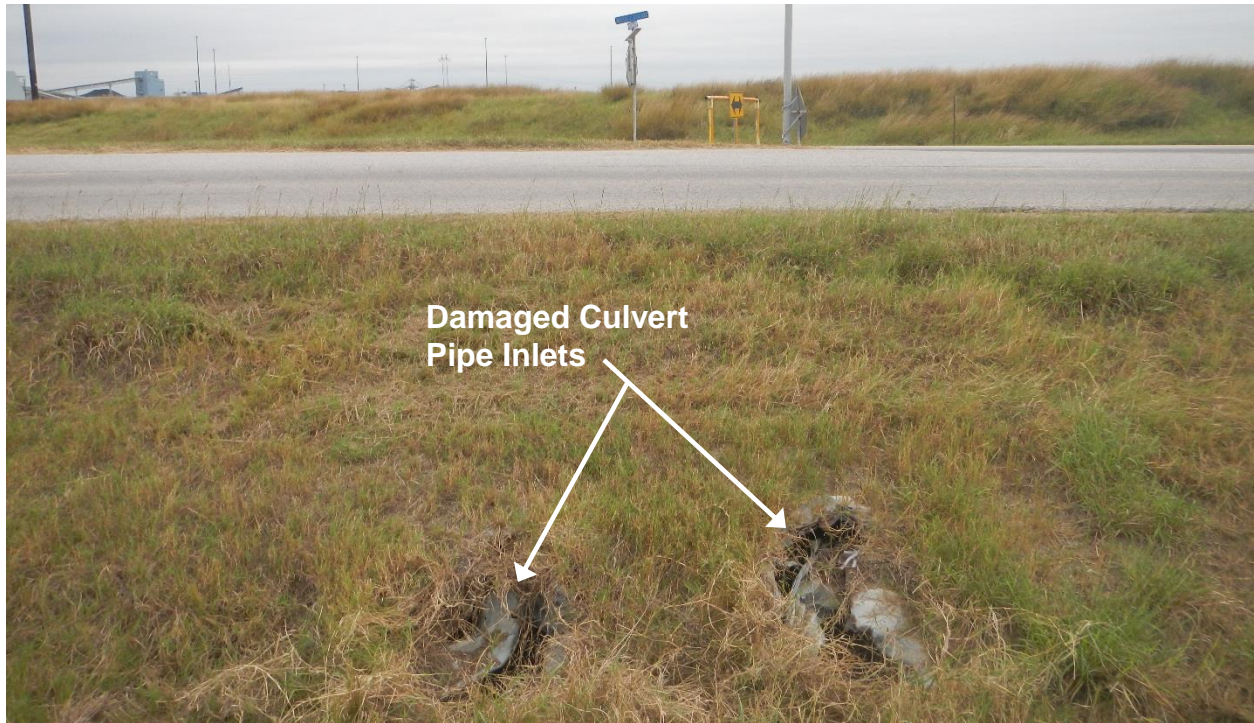
(1) Minor damage was identified at one of the corrugated metal drainage culverts which convey non-contact runoff from the closed northern slope section beneath the Austin Loop plant road. The mitered end matching the slope was bent and partially blocking the opening which will impede design flow. It is likely the metal culvert inlets were bent inwards during grass mowing activities and should be repaired to ensure proper drainage is maintained. (See Photo 1).

**PHOTO 1 – View of North Embankment drainage culverts looking Northeast (11-8-2017)**

- Item 2017-001, Repair damaged inlet sections of corrugated metal drainage culverts which convey non-contact runoff from the northern embankment section beneath the plant road.
- Item 2017-002, Repair damaged corrugated metal drainage culvert ends near the intersection of Future Subcell 2A, 2B and Existing Subcell 2D, which convey contact runoff via the Runoff Channel from Existing Cell 1 beneath the access road to the Existing Runoff Retention Pond..

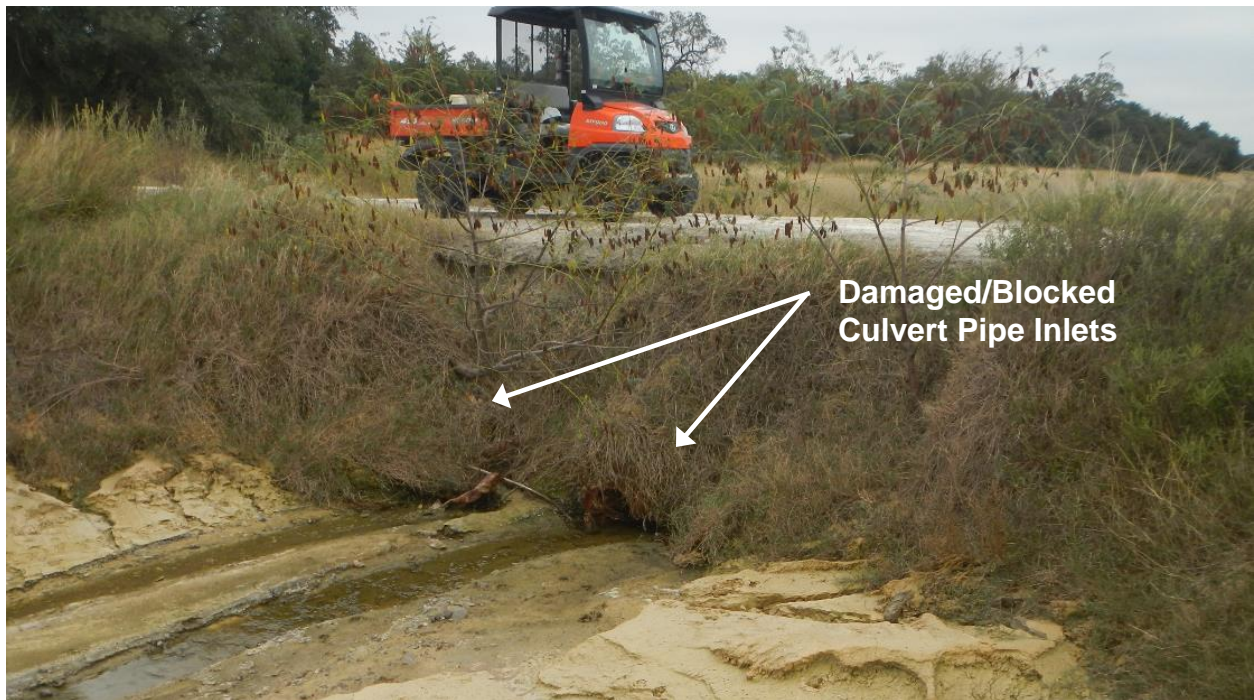
(2) Damage was identified at the two roadway crossing corrugated metal drainage culverts, which convey contact runoff from Existing Cell 1 to the Existing Runoff Retention Pond near the intersection of Future Subcell 2A, 2B and Existing Subcell 2D. The mitered ends matching the slope are bent and blocking the openings on both sides which will impede design flow. These culverts should be repaired to ensure proper drainage is maintained. (See Photos 2 and 3).

**PHOTO 2 – View of Cell 1 Stormwater Channel culverts looking Southeast (11-8-2017)**

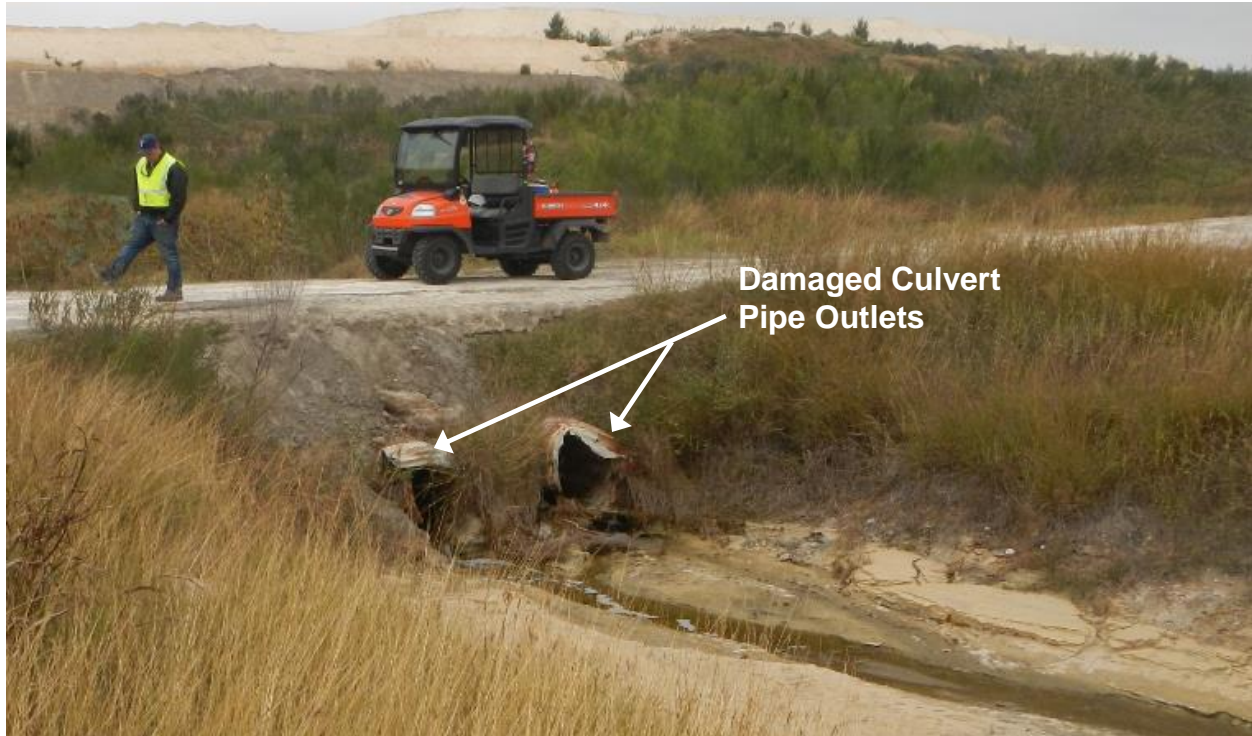
**PHOTO 3 – View of Cell 1 stormwater channel culverts looking Northeast (11-8-2017)**

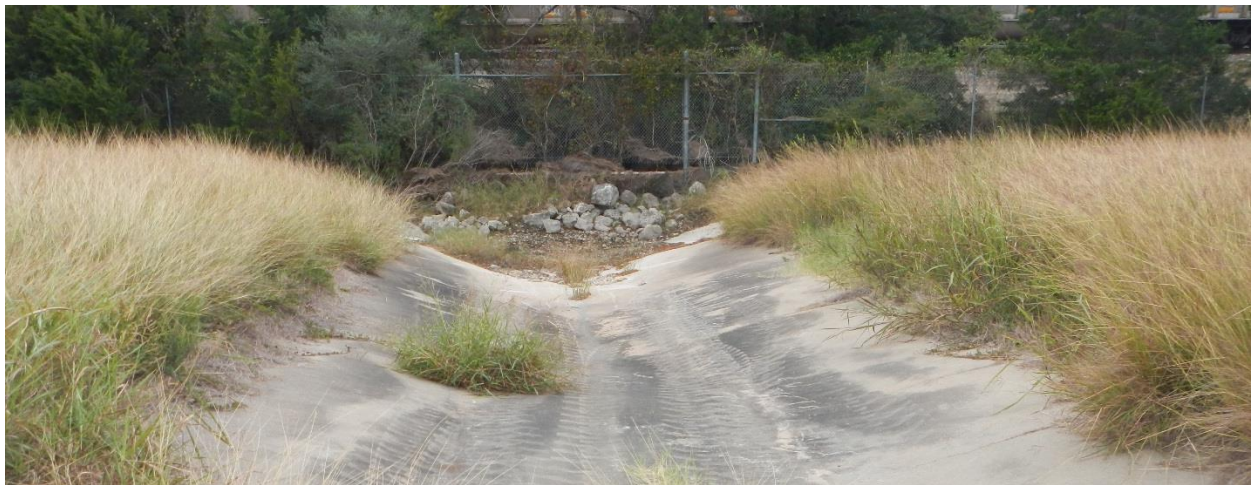
(3) It was identified that removal of the cactus and brushy growth partially obstructing the Combustion Byproducts Landfill (CBL) Runoff Pond spillway was completed which was identified during last year's inspection. Some grass has regrown in a joint and should be removed as part of normal vegetation maintenance. (See Photo 4).

**PHOTO 4 – View of cleared CBL Runoff Pond Spillway Looking South (11-18-2017)**

- Item 2016-001, It was identified during the 2017 inspection that the cactus and brushy growth blocking the CBL Runoff Pond spillway noted in Section 4.6, Comment 2 has been removed. Continued vegetative controls should be implemented to ensure the spillway channel remains clear.

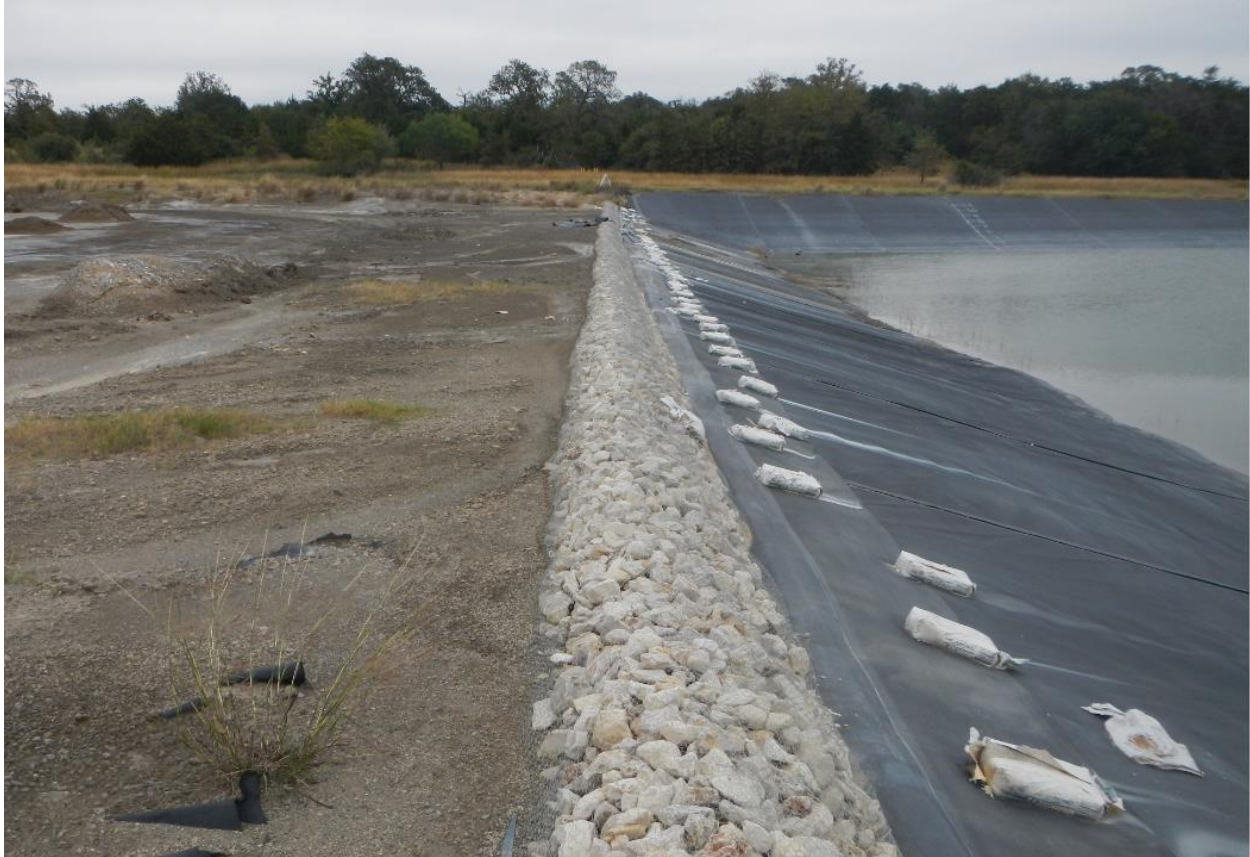
(4) Repair was completed of the Subcell 2D rock silt berm synthetic liner transition apron that had come apart at the top of the north slope of the Subcell 2D Contact Water Retention Pond identified during the 2016 inspection. (See Photo 5).

**PHOTO 5 – View of repaired Subcell 2D Pond North Slope Rock Silt Berm (11-8-2017)**

- Item 2016-002, Repairs were completed to the Subcell 2D rock silt berm transition apron. The rock silt berm synthetic liner transition apron had come apart at the top of the Subcell 2D Pond north slope. While synthetic liner was used as part of this silt control measure, this was not a part of the pond liner system and the pond liner remained intact.
