**ANNUAL CCR LANDFILL INSPECTION
40 CFR §257.84(b)**

**FAYETTE POWER PROJECT
COMBUSTION BY-PRODUCTS LANDFILL**

**PREPARED FOR
LCRA
FAYETTE POWER PROJECT**

**PREPARED BY
LCRA ENGINEERING SERVICES
January 13, 2020**

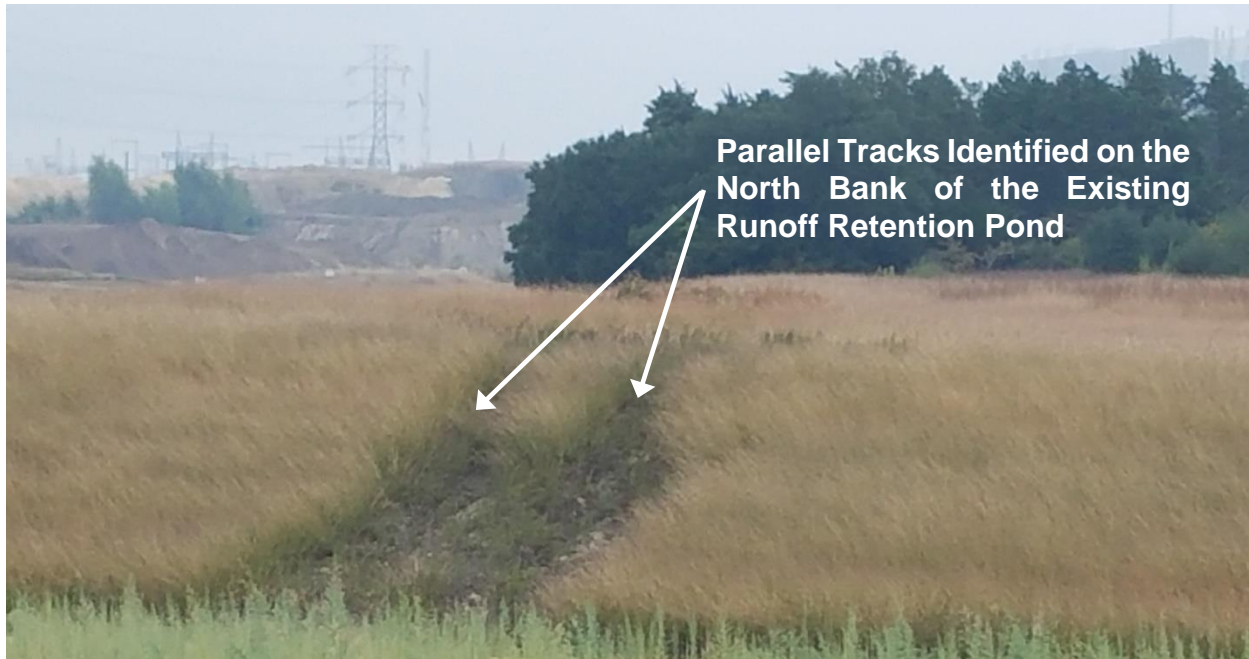
(2) Minor rutting on the Cell 1 pond north cut bank was identified during the annual inspection (See Photo No. 01). The rutting appeared to be caused by a track mounted equipment used to remove sediment buildup in the pond. No soil depressions were observed but a pair of slight vegetative discontinuities running parallel up the slope were visually apparent. The area should be mowed and reseeded during normal vegetative control operations to ensure full vegetative coverage is maintained.

Parallel Tracks Identified on the North Bank of the Existing Runoff Retention Pond

PHOTO 1 – View of vegetative discontinuity identified on the Cell 1 Existing Runoff Retention Pond North cut bank (11-07-2019)

- Item 2019-002, restore vegetative cover in the area of discontinuity identified during the annual inspection on the existing Cell 1 Contact Water Runoff retention Pond North cut bank. The area should be mowed and reseeded during normal vegetative control operations to ensure full vegetative coverage is maintained.

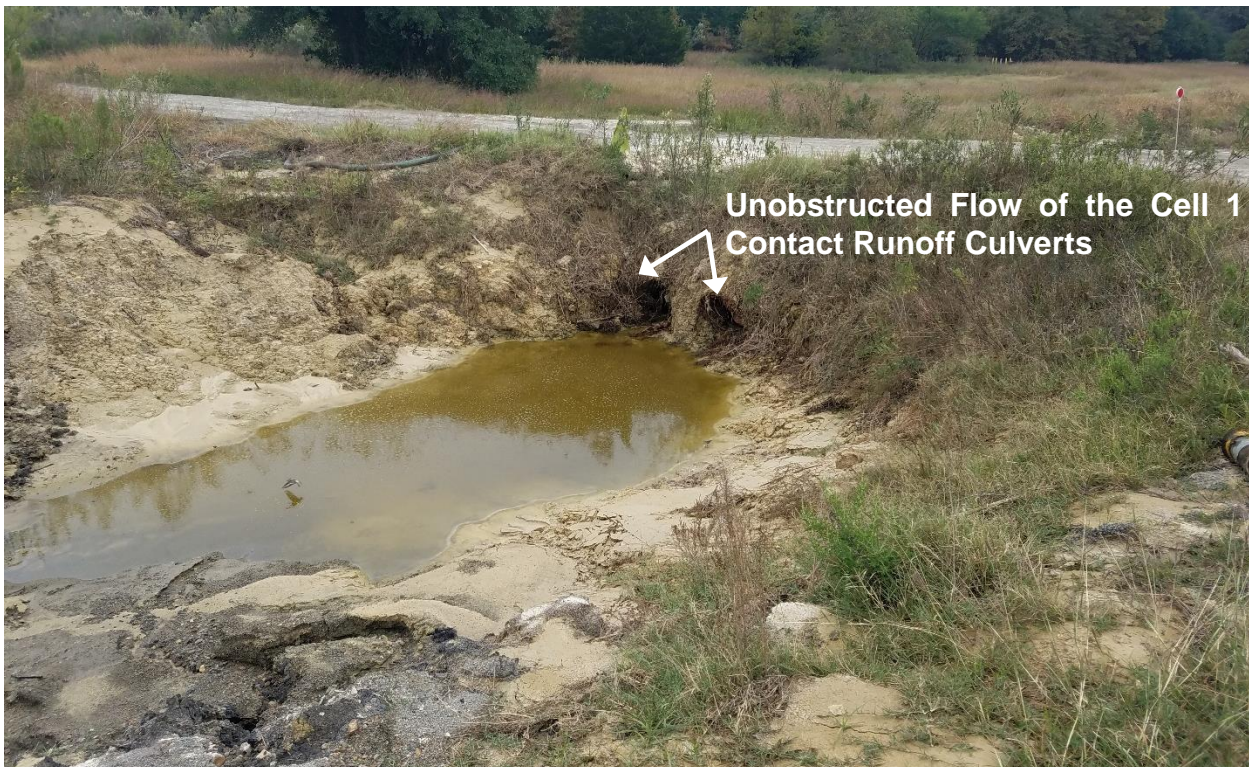
(1) The weekly inspection report from February 6, 2019 notes that the heavy silting identified during the prior inspection period of the corrugated metal drainage culverts beneath the site access road and which convey contact runoff from Existing Cell 1 to the Existing Runoff Retention Pond was removed. The culvert was observed to be unblocked and free flowing during the annual inspection (See Photos Nos. 2 & 3).

Unobstructed Flow of the Cell 1 Contact Runoff Culverts

PHOTO 2 – View of unblocked inlets for Cell 1 stormwater channel culverts looking South (11-07-2019)

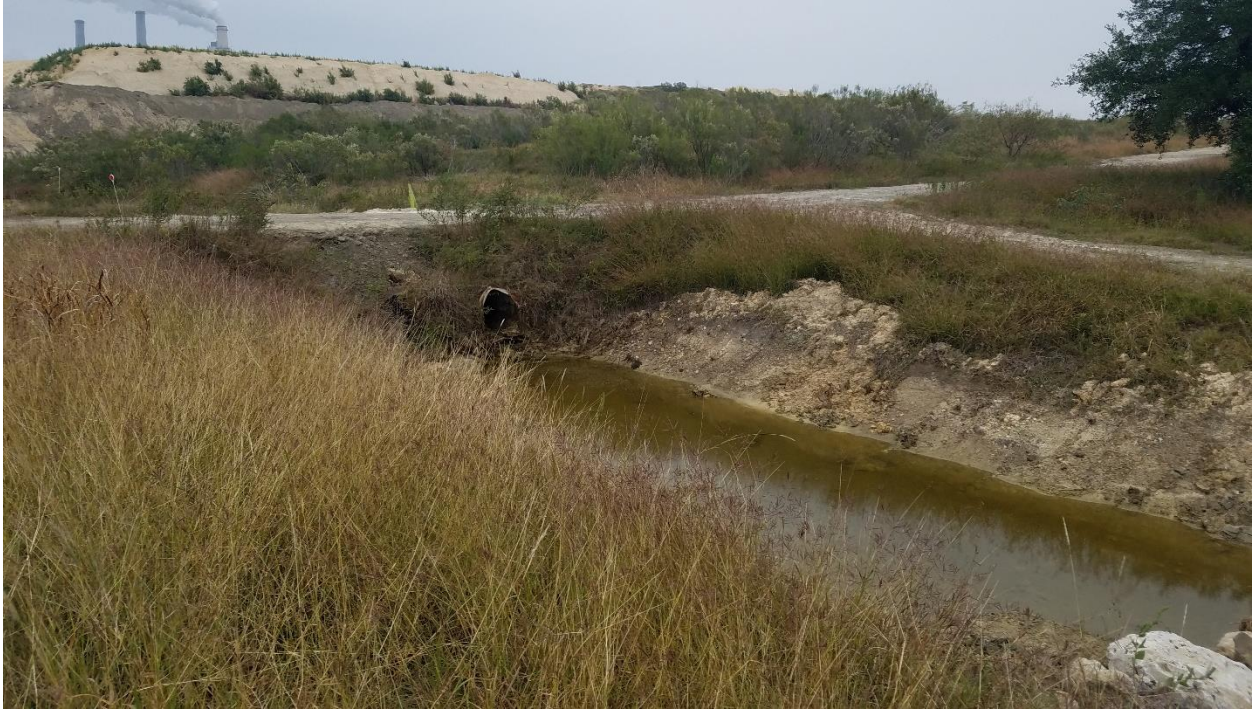
PHOTO 3 – View of unblocked Cell 1 stormwater channel culvert outlets looking North (11-07-2019)

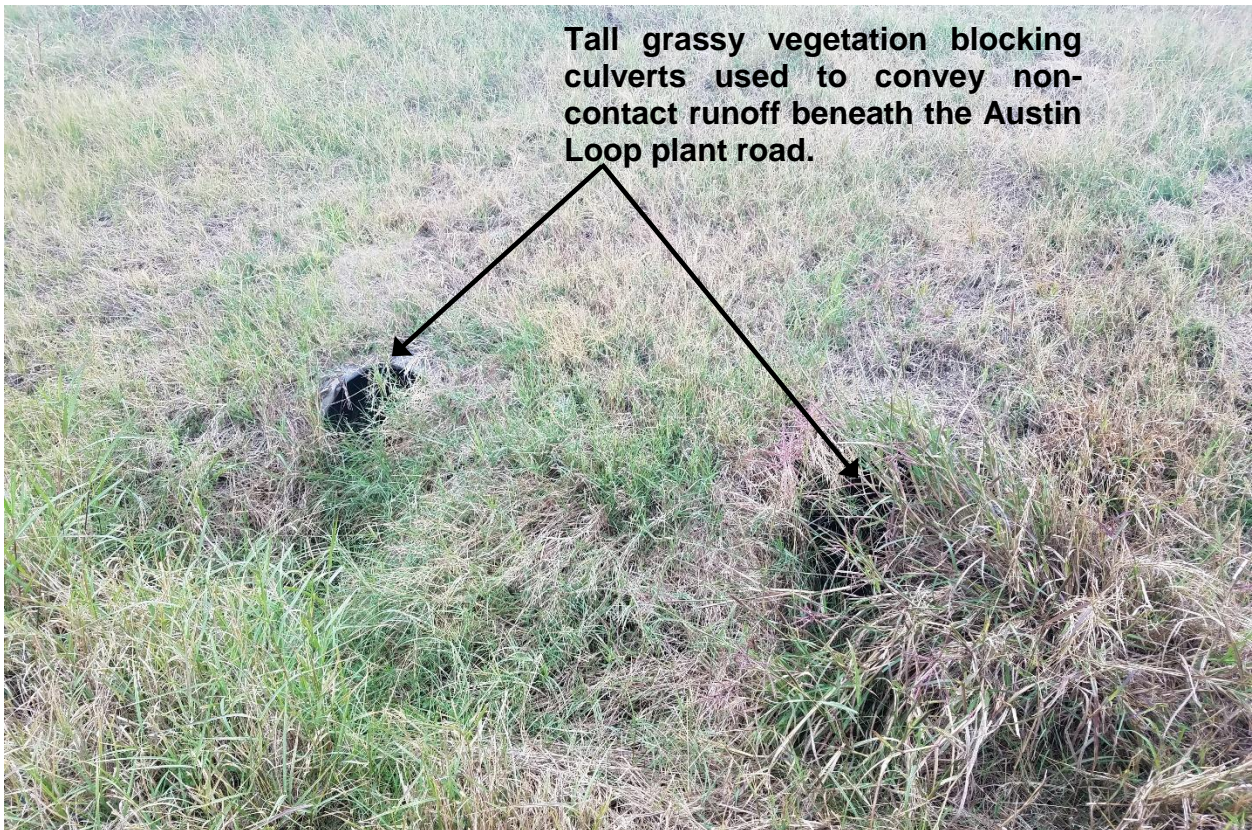
(2) Tall grassy vegetative growth was identified in front of the inlets of the corrugated metal drainage culverts which convey non-contact runoff from the closed northern slope section beneath the Austin Loop plant road (See Photo No. 4). The tall grass should be trimmed during normal vegetative control activities to prevent blockage and maintain an unobstructed flow.

Tall grassy vegetation blocking culverts used to convey non-contact runoff beneath the Austin Loop plant road.

PHOTO 4 – View of grassy vegetation blocking culverts northeast of Cell 1 (11-7-2019)

- Item 2019-003, tall grassy vegetation identified in front of the inlets of the corrugated metal drainage culverts which convey non-contact runoff from the closed northern slope section beneath the Austin Loop plant road should be trimmed during normal vegetative control measures to ensure an unobstructed flow is maintained.

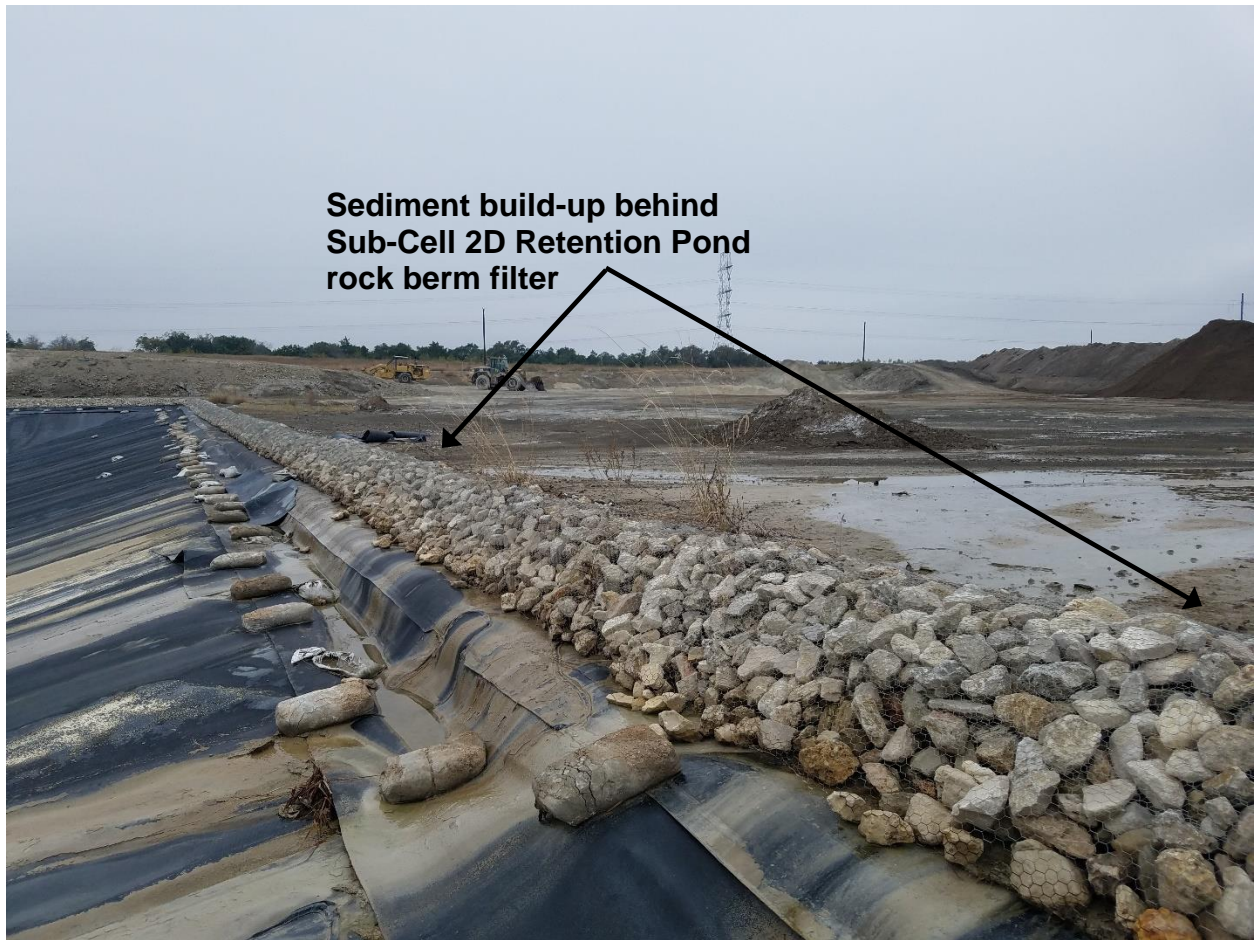
(3) Excessive sediment buildup was identified behind the rock berm filter located at the Sub-Cell 2D Contact Runoff Retention Pond (See Photo No. 5). Excessive sediment should be removed from behind the rock berm structure sufficient to maintain an unobstructed flow through the berm and prevent silt accumulation in the pond area.

PHOTO 5 – View of excessive sediment build-up behind rock berm filter (11-07-2019)

- Item 2019-004, excessive sediment buildup identified behind the rock berm filter at the Sub-Cell 2D Contact Runoff Retention Pond should be removed from behind the rock berm structure sufficient to maintain an unobstructed flow and prevent silt accumulation in the pond area.
