**ENGINEERING REPORT**

**ANNUAL CCR LANDFILL INSPECTION**

**FAYETTE POWER PROJECT  
COMBUSTION BY-PRODUCTS LANDFILL**

**PREPARED BY  
LCRA ENGINEERING SERVICES  
January 15, 2021**

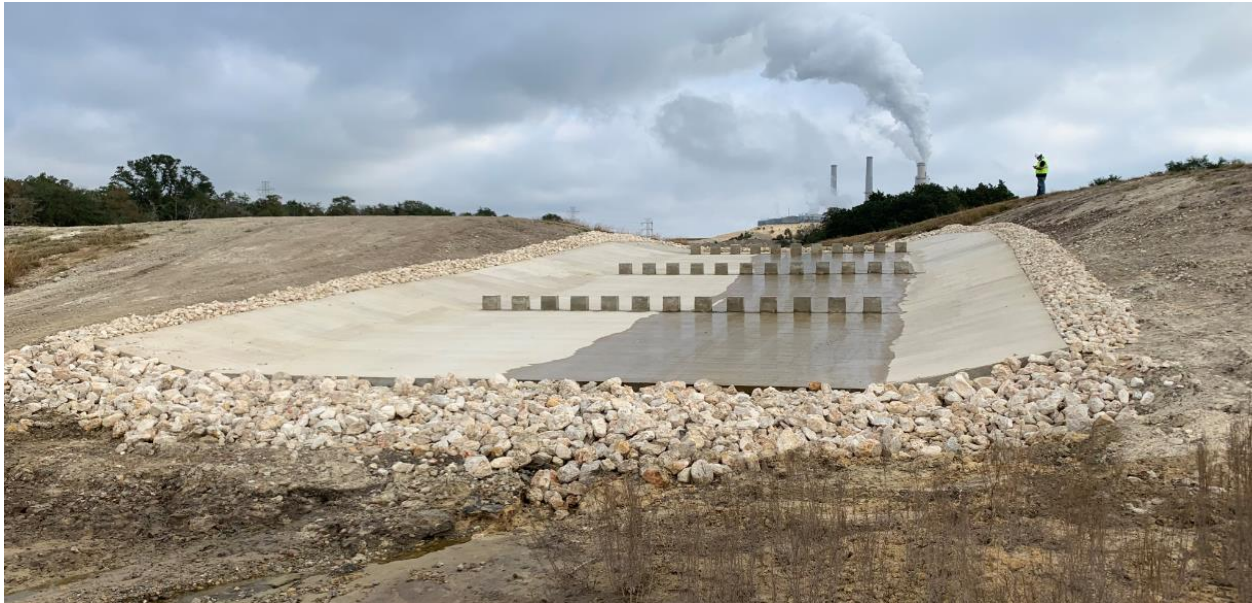
(1) A new discharge structure was added to the CBL Pond slope with energy dissipater blocks to convey flow from the CBL Runoff Chanel to the pond (See Photo No. 1).

**PHOTO 1 – View of new CBL Channel Discharge Structure at the CBL Pond (11-13-2020)**

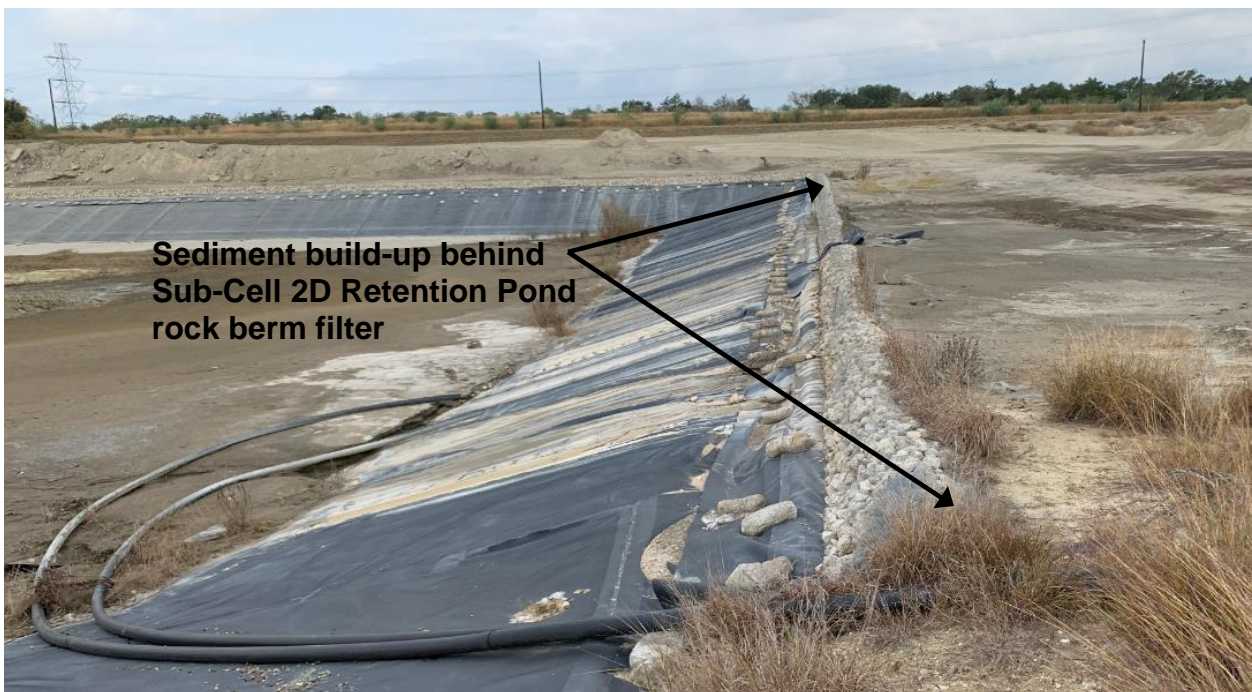
(2) Excessive sediment buildup was again identified behind the rock berm filter located at the Sub-Cell 2D Contact Runoff Retention Pond (See Photo No. 2). Waste Management, Inc. (WMI) inspects and maintains this area and it was reported that material was removed in January 2020. WMI should continue to monitor the area and if excessive sediment is identified, it should be removed from behind the rock berm structure to maintain an unobstructed flow through the berm and prevent excessive silt accumulation in the pond area.

**PHOTO 2 – View of excessive sediment build-up behind rock berm filter (11-13-2020)**

- Item 2019-004, excessive sediment buildup identified behind the rock berm filter at the Sub-Cell 2D Contact Runoff Retention Pond should be removed from behind the rock berm structure sufficient to maintain an unobstructed flow and prevent silt accumulation in the pond area.

**In January 2020, it was reported WMI removed material from behind the rock berm. The excessive buildup was again present at this time of inspection and should be removed and monitored regularly. The inspection of this area will be added to the monthly inspection required by TPDES Permit 0002105000 and will no longer be included in this annual inspection report.**
