ENGINEERING REPORT

**ANNUAL CCR LANDFILL INSPECTION
40 CFR §257.84(b)
30 TAC §352.841**

**FAYETTE POWER PROJECT
COMBUSTION BY-PRODUCTS LANDFILL**

**PREPARED BY
LCRA ENGINEERING SERVICES
January 12, 2022**

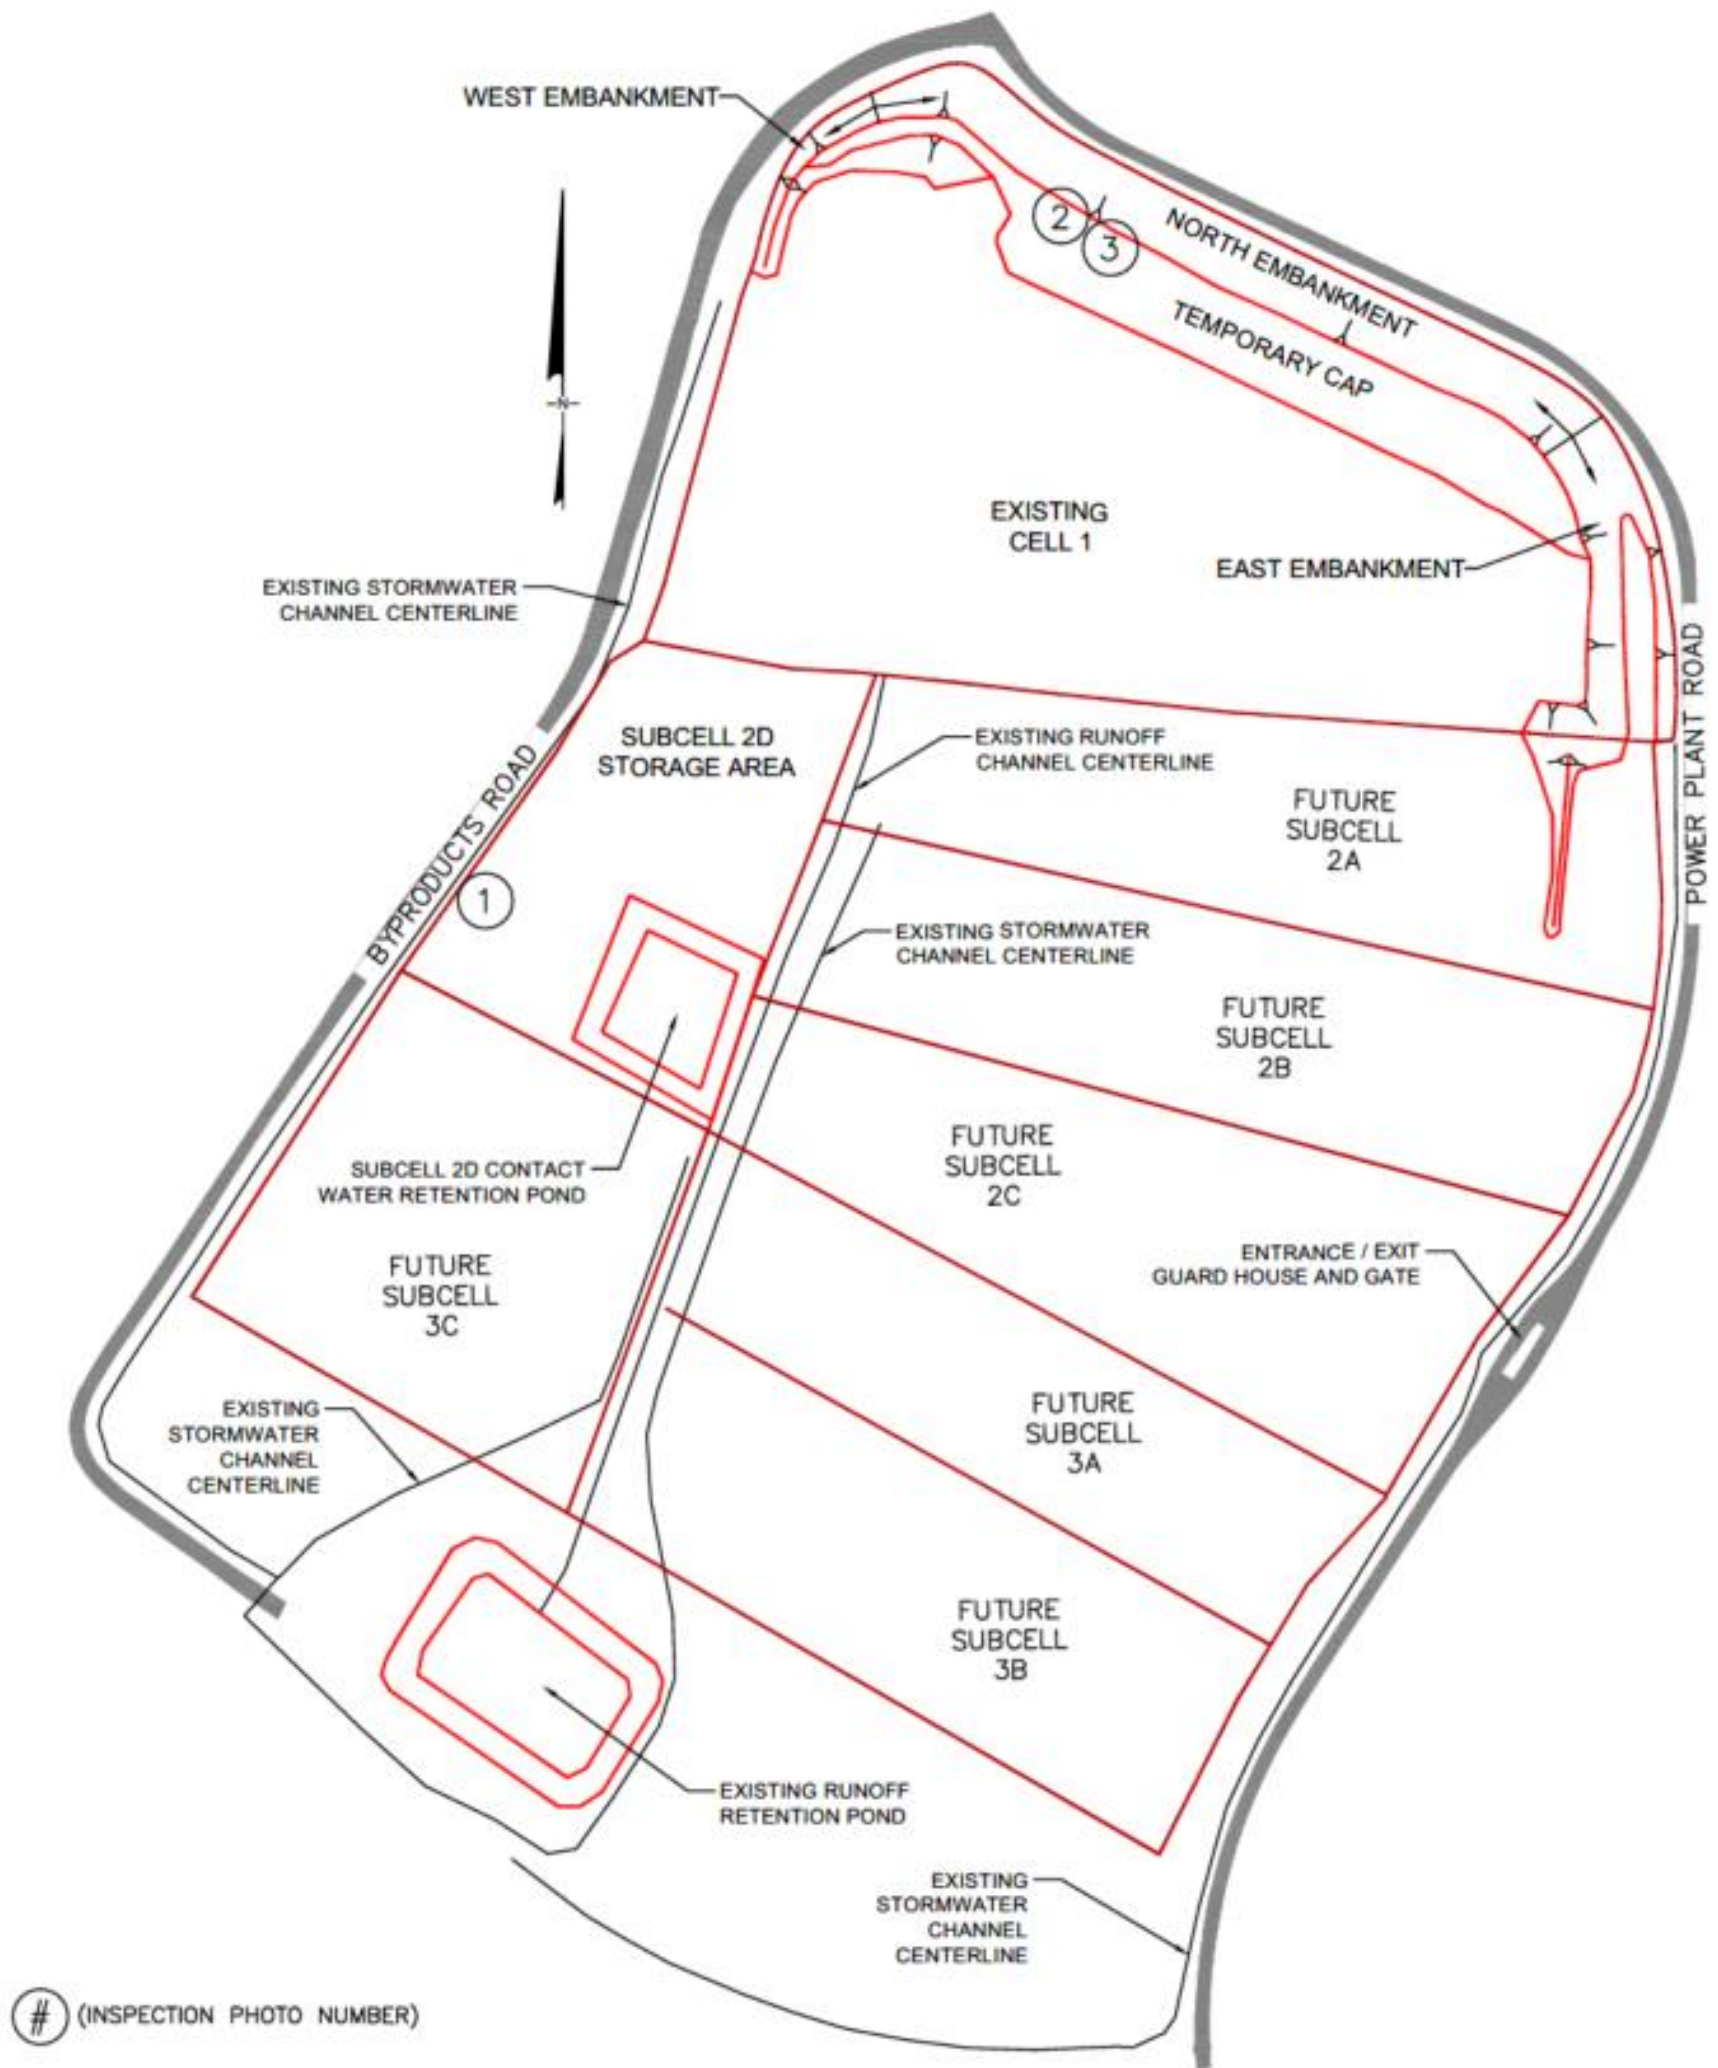
FPP COMBUSTION BY-PRODUCTS LANDFILL INSPECTION DRAWING

An aerial survey was conducted on October 5, 2021 and did not show a change in the landfill impounding structure geometry from the November 23, 2020 survey. This was also confirmed during the field inspection. An approximate layout of the impounding structures is included in Appendix B.

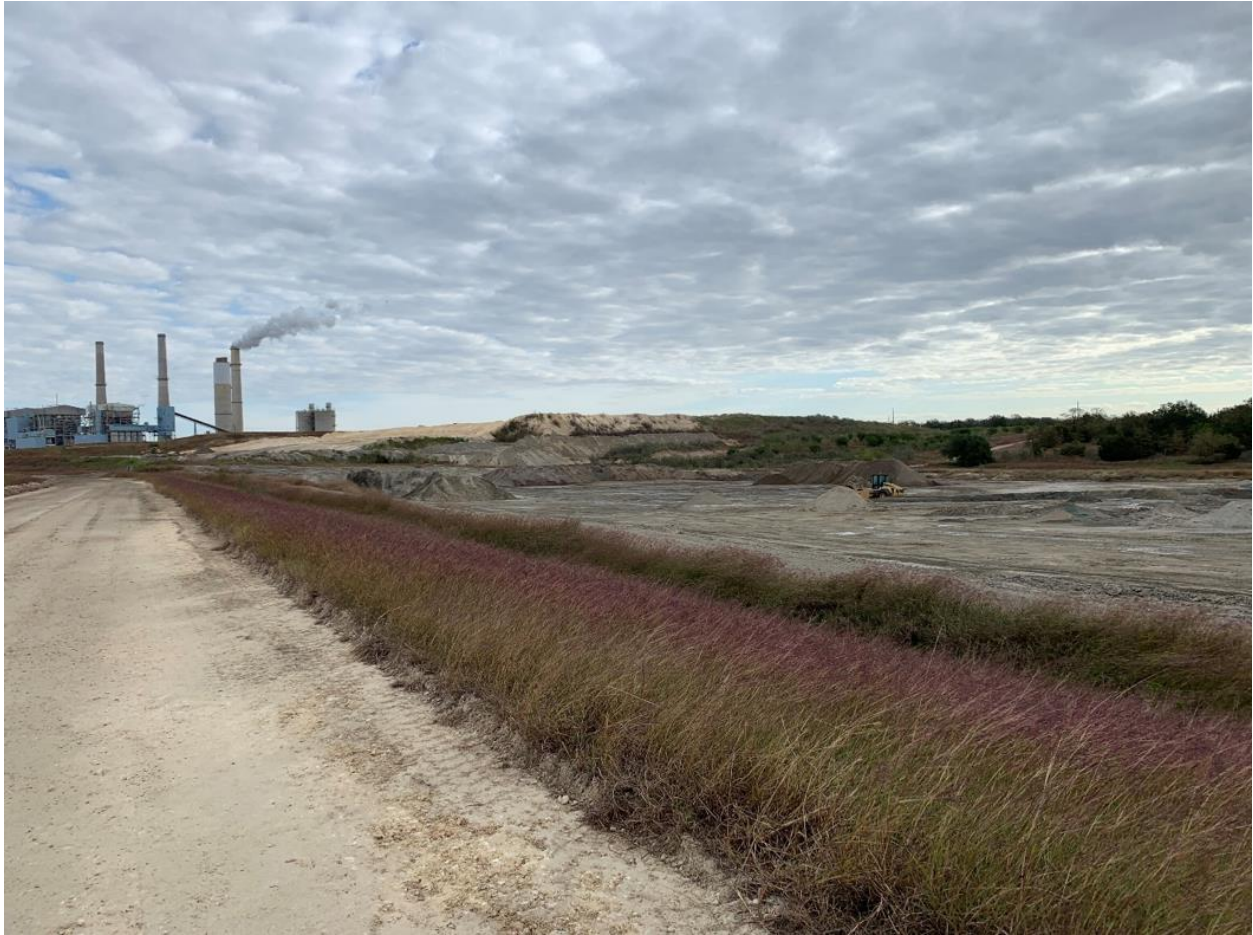
PHOTO 1 – View of active CBL Cell 1 & 2D (11-18-2021)

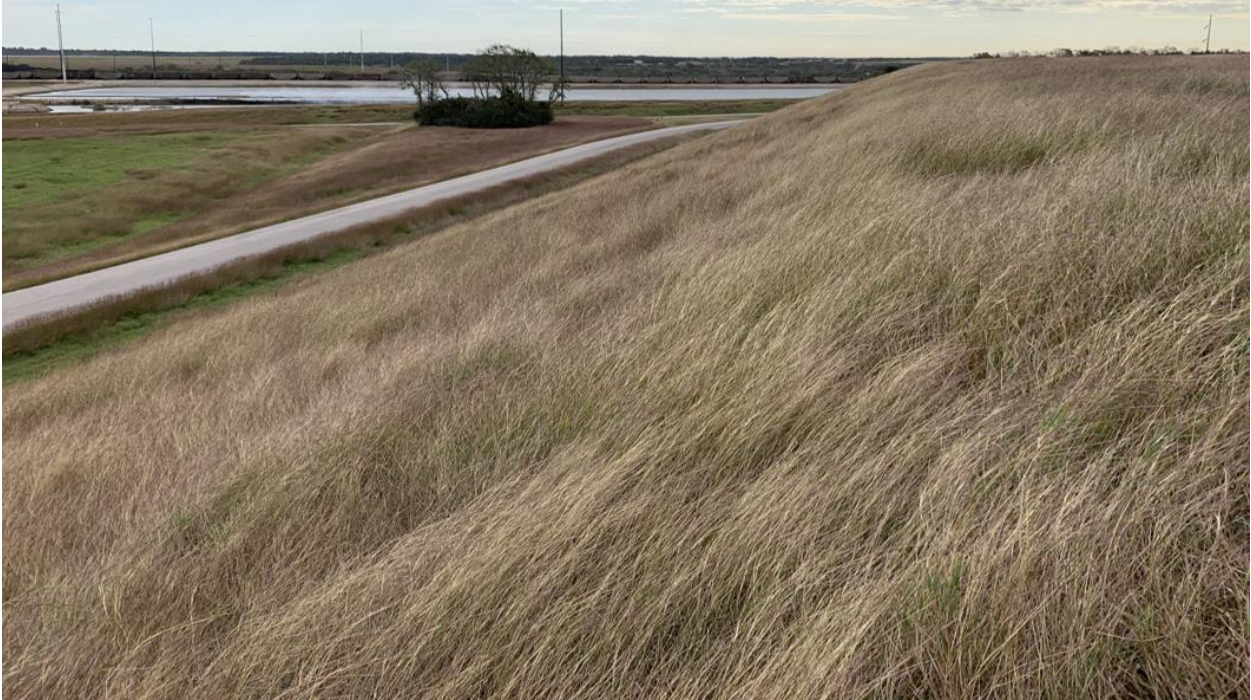
(1) Overall, grass cover was in good condition with full coverage. During the initial inspection grass was observed with an approximate height of 12 to 36-inches. A follow-up inspection was conducted shortly after the cover area had been mowed and was observed with an approximate height of 3 to 6-inches. There were no visual signs of active animal activity or history of such. The slopes are visually in alignment with the 3:1 design and no visual evidence of structural issues were observed.

PHOTO 2 – View of Cell 1 North Embankment Slope during initial inspection (11-18-2021)

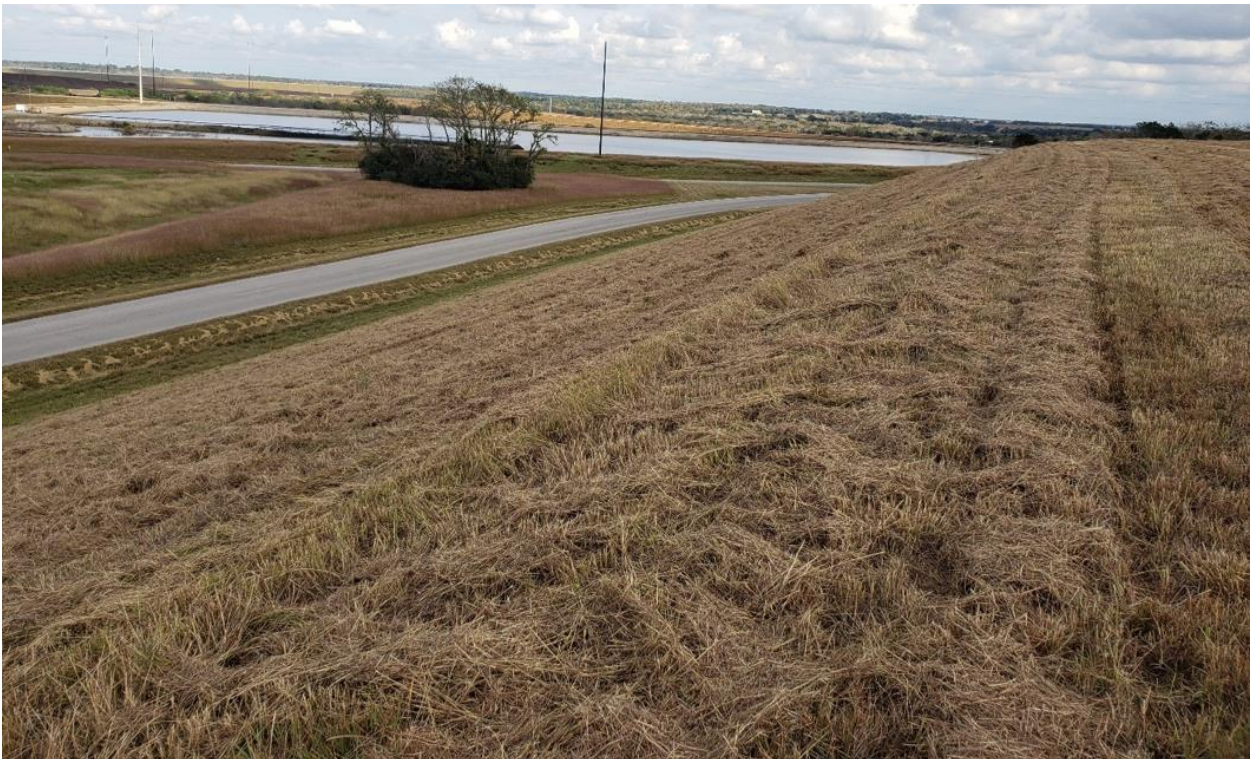
PHOTO 3 – View of Cell 1 North Embankment Slope during follow-up inspection (12-02-2021)
