2017 BASIN SUMMARY REPORT

A Summary of Water Quality Activities
in the Colorado River Basin (2012-2016)

This report, which summarizes water quality activities in the Colorado River basin between January 2012 and December 2016, was prepared by the Lower Colorado River Authority (LCRA) and Upper Colorado River Authority (UCRA) with contributions from the City of Austin. The report was financed through grants from the Texas Commission on Environmental Quality (TCEQ).

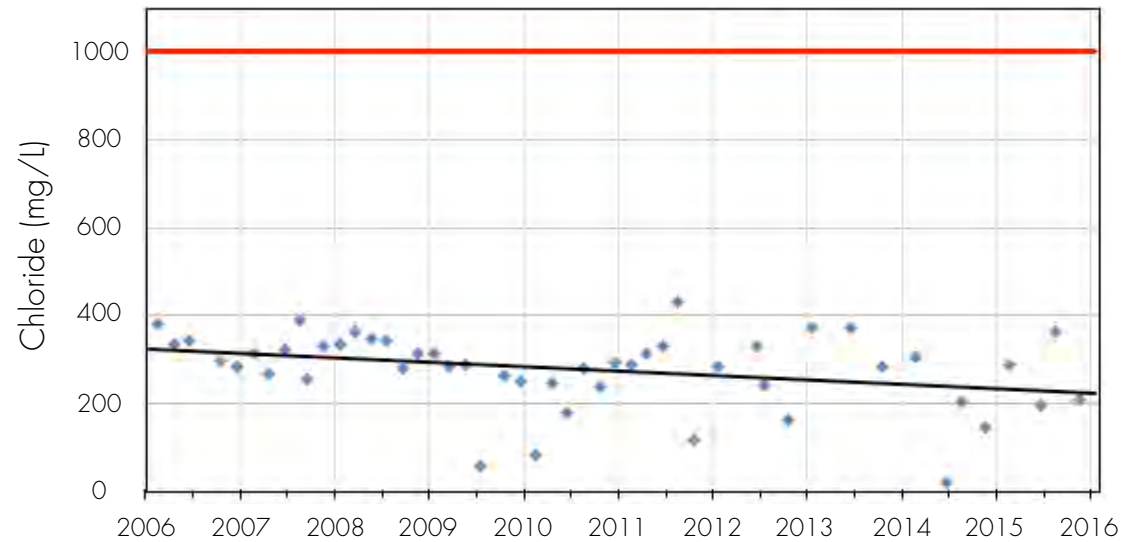
Figure 14. Chloride Trend / Segment 1426C

Figure 14 presents one statistically significant trend analysis performed on the 2014 Integrated Report data. It shows a declining trend in chloride. The cause of this improving trend in chloride is unknown, but may be attributable to increased flows.

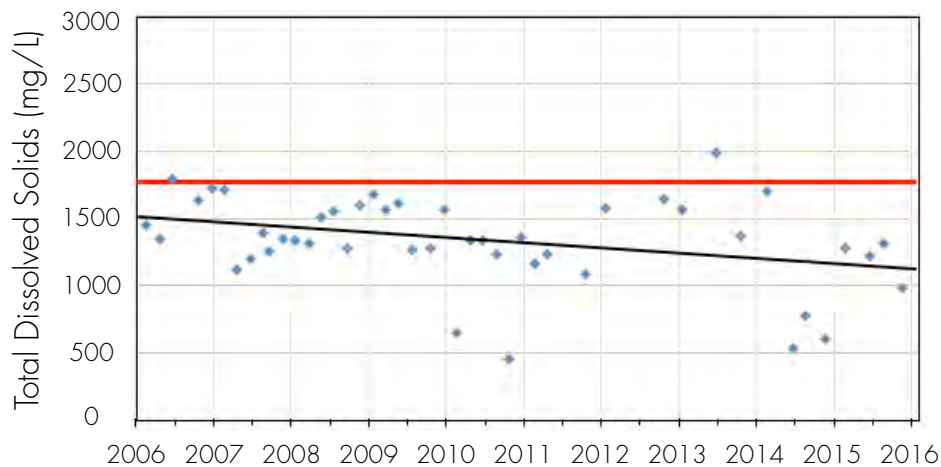
Figure 16. Total Dissolved Solids / Segment 1426D

Figures 15-17 present three statistically significant trend analyses. The analyses of chloride and TDS levels show significantly decreasing trends, while the pH values exhibit a flat trend. The reason for the improvements in chloride and TDS are unknown. However, both graphs show higher values during the period of drought from 2012 through 2014. Therefore, the improvements may be associated with increased flows.

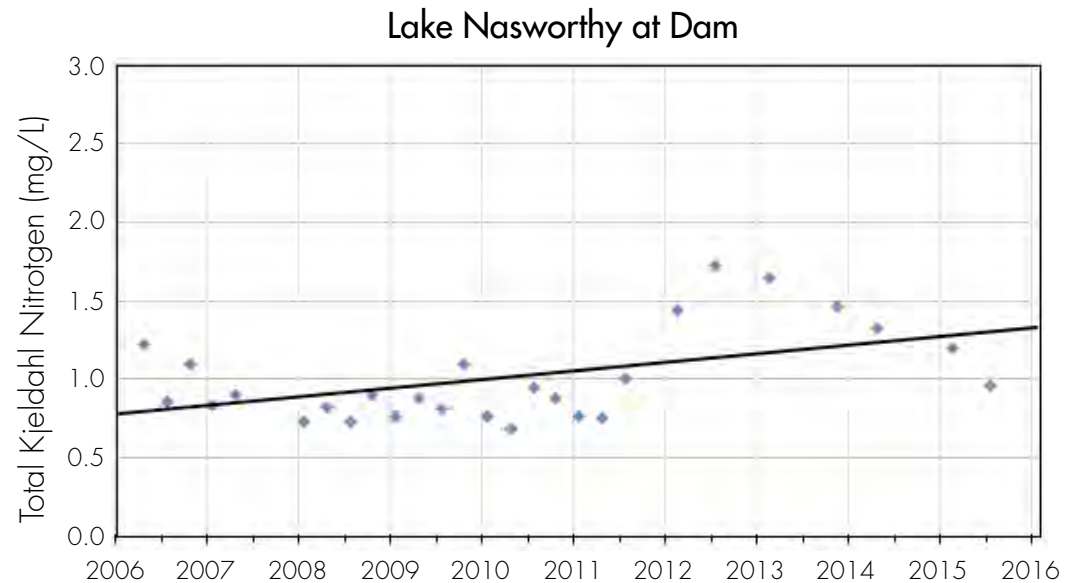
Figure 27. Total Kjeldahl Nitrogen Trend / Segment 1422

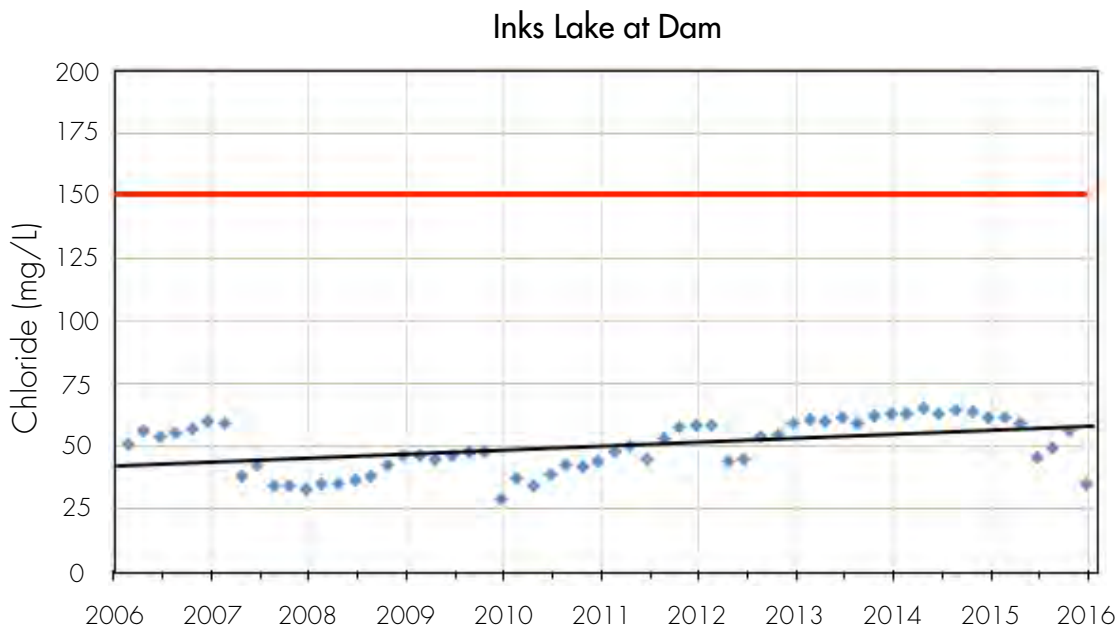
Figure 66. Chloride Trend / Inks Lake

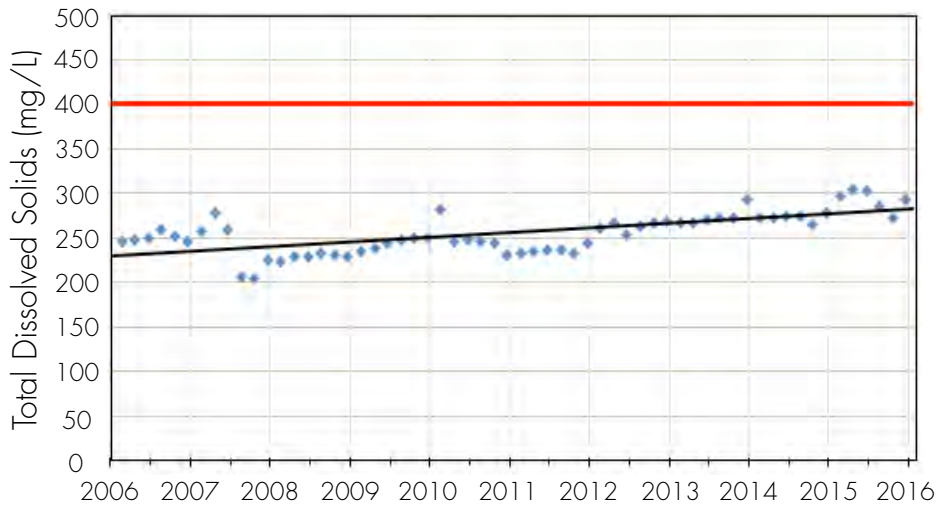
Figure 78. Total Dissolved Solids Trend / Metropolitan Park
