2020 Colorado River Basin Highlights Report

A SUMMARY OF WATER QUALITY
IN THE COLORADO RIVER BASIN

PREPARED BY THE LOWER COLORADO RIVER AUTHORITY
AND THE UPPER COLORADO RIVER AUTHORITY
in cooperation with the Texas Commission on Environmental Quality
under the authorization of the Texas Clean Rivers Act.

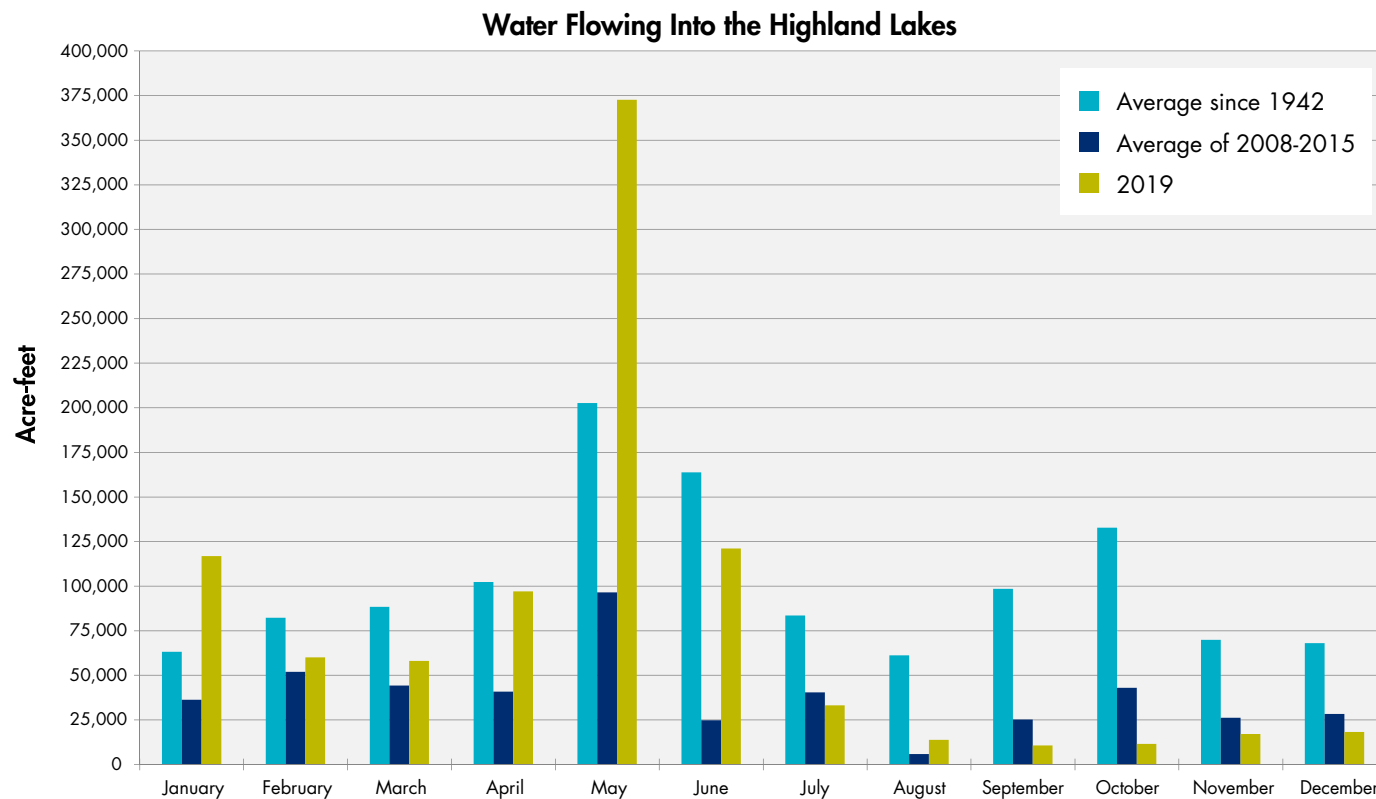
*Inflows: the estimated amount of water flowing into the Highland Lakes from rivers and streams

Data for 2018 and 2019 is preliminary and subject to change.

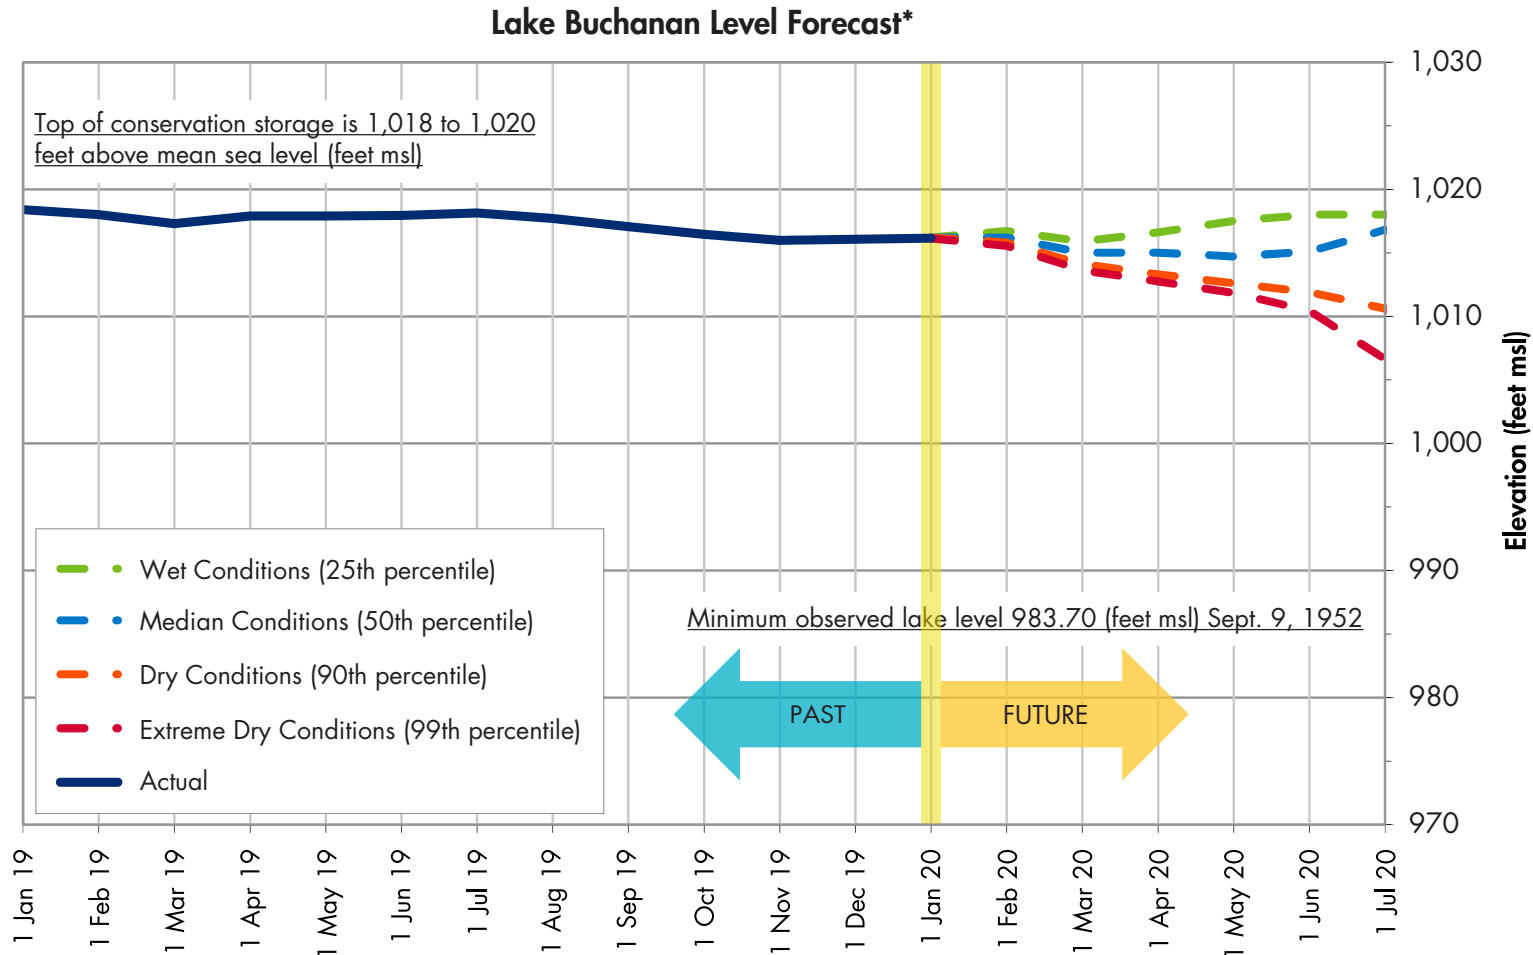
*Based on results from the draft stochastic model under development to reflect provisions of the 2015 Water Management Plan.

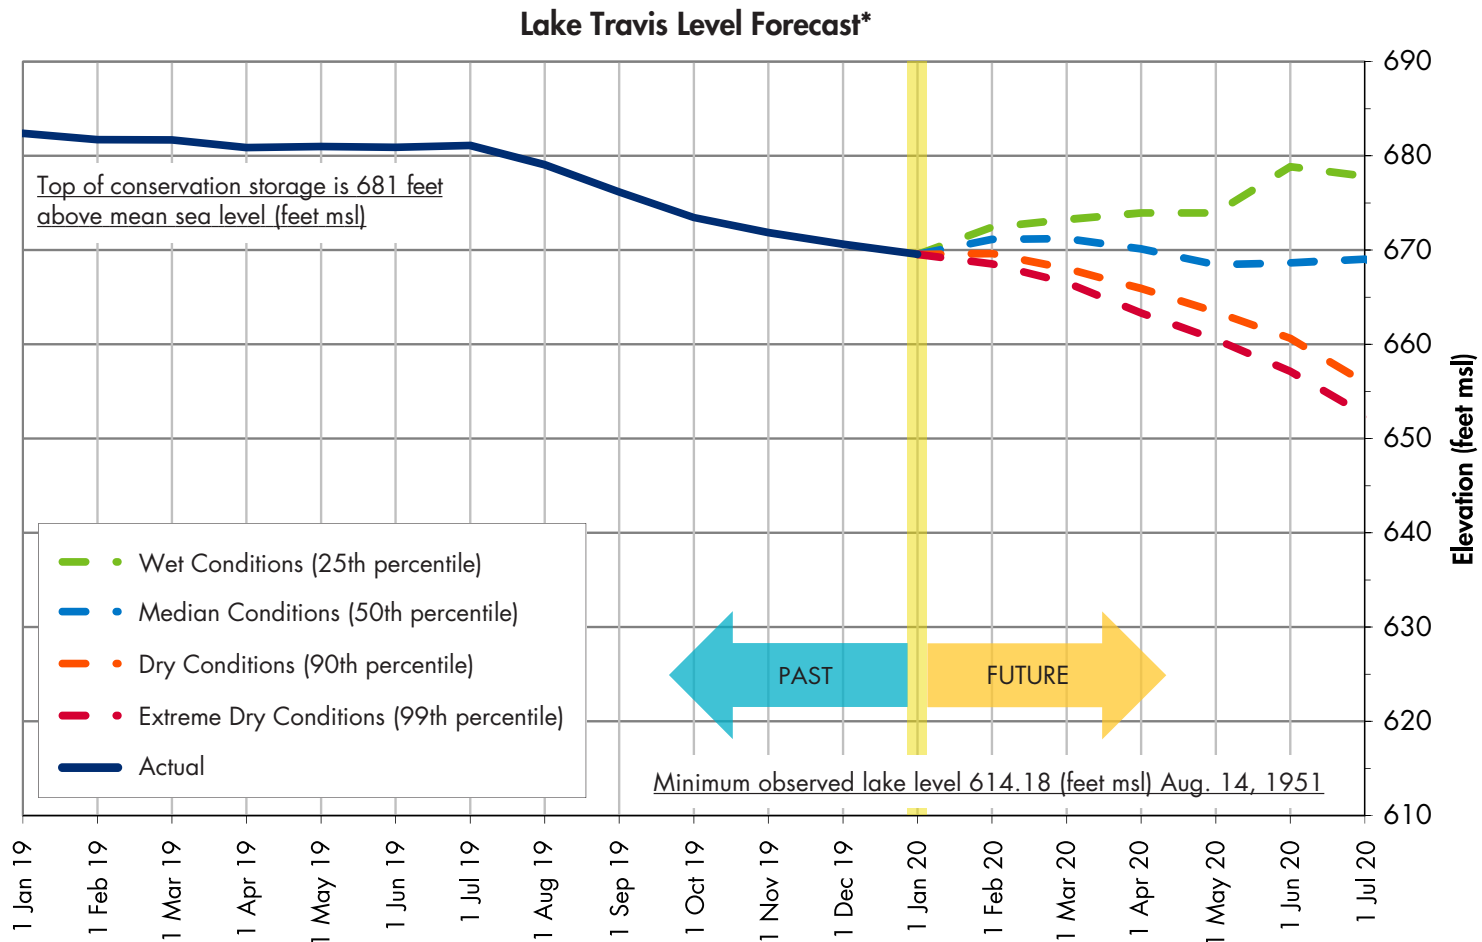
*Based on results from the draft stochastic model under development to reflect provisions of the 2015 Water Management Plan.
