Texas Clean Rivers Program

— 2021 Basin Highlights Report

A Characterization of
Impaired Water Bodies in the
Lower Colorado River Basin

May 15, 2021

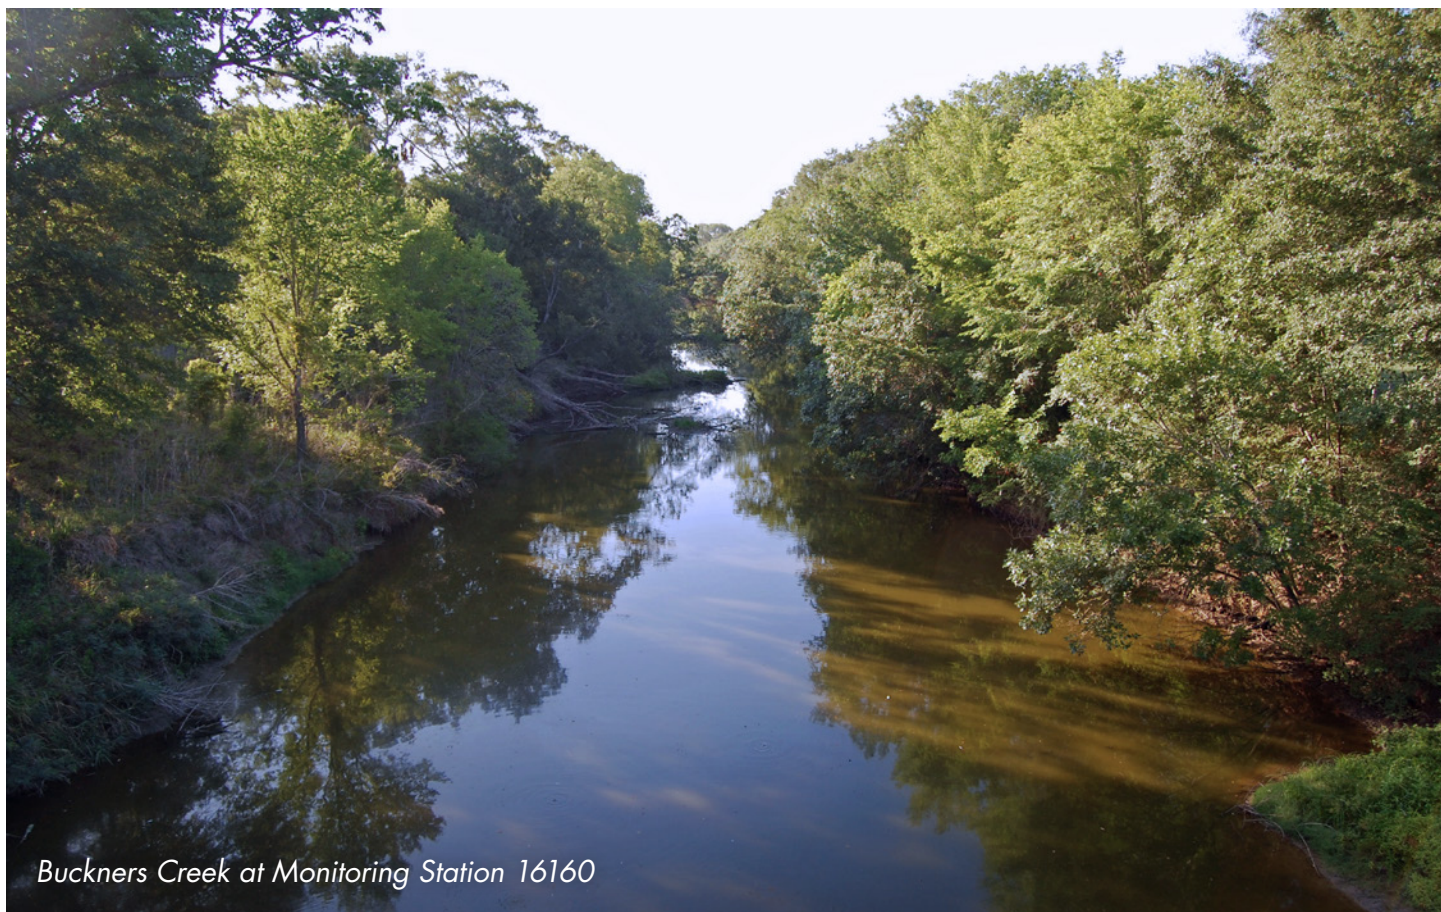
Buckners Creek at Monitoring Station 16160

16160 – Buckners Creek approximately 200 feet upstream of Fayette County Road 154

During the period of record, flow data in Buckners Creek ranged from no flow to 390 cubic feet per second (cfs). Of 15 sampling events, only three were above 1 cfs. The seasonal hydrology of the creek is typical (lower flows in hotter months and higher flows in the cooler periods).
